SHAWNEE COUNTY
PARKS AND RECREATION

**RECREATION
— CENTER —
ASSESSMENTS**

Topeka, Kansas

MAY 2014

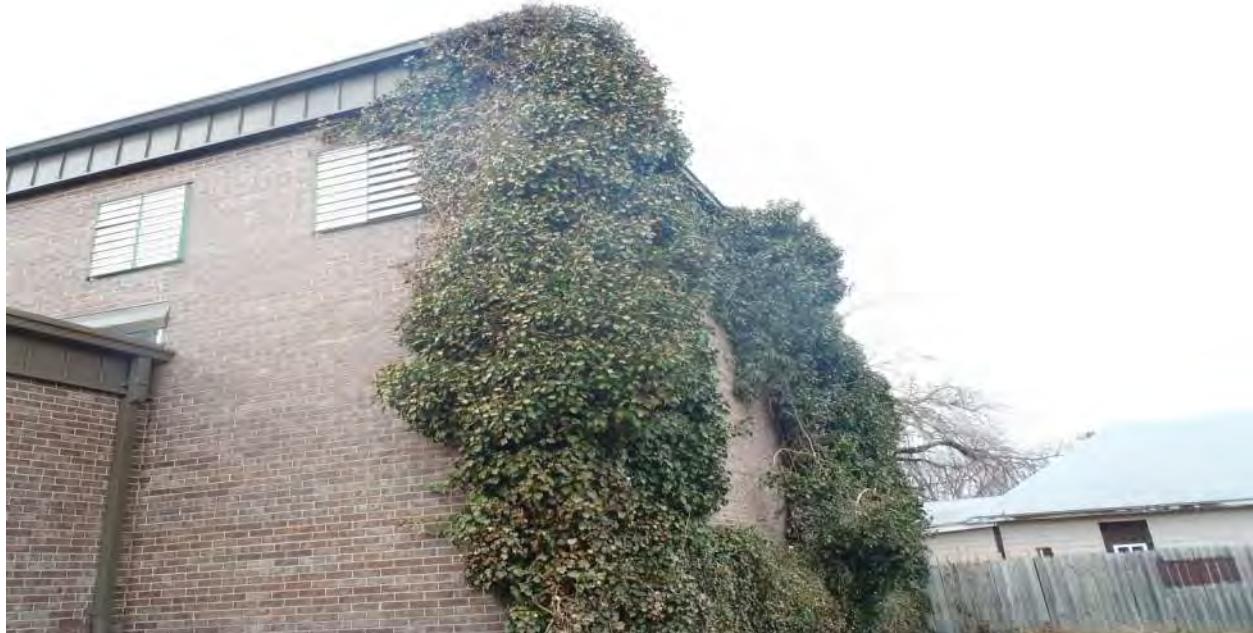
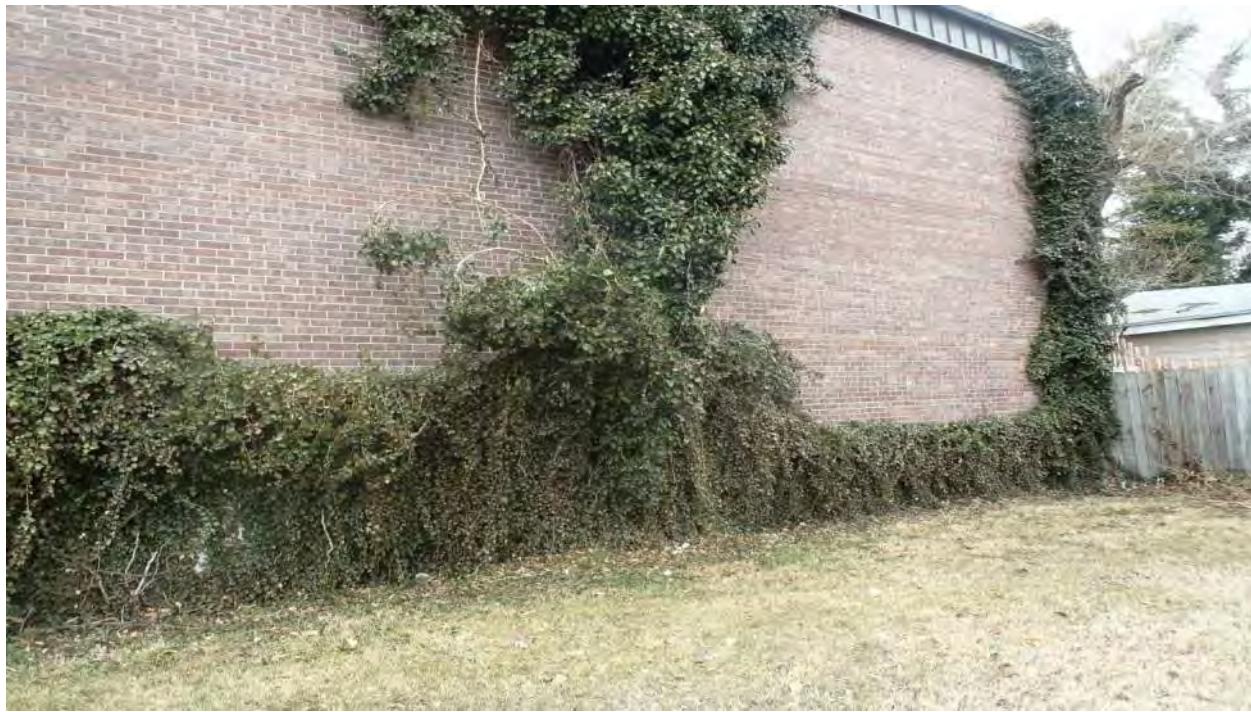
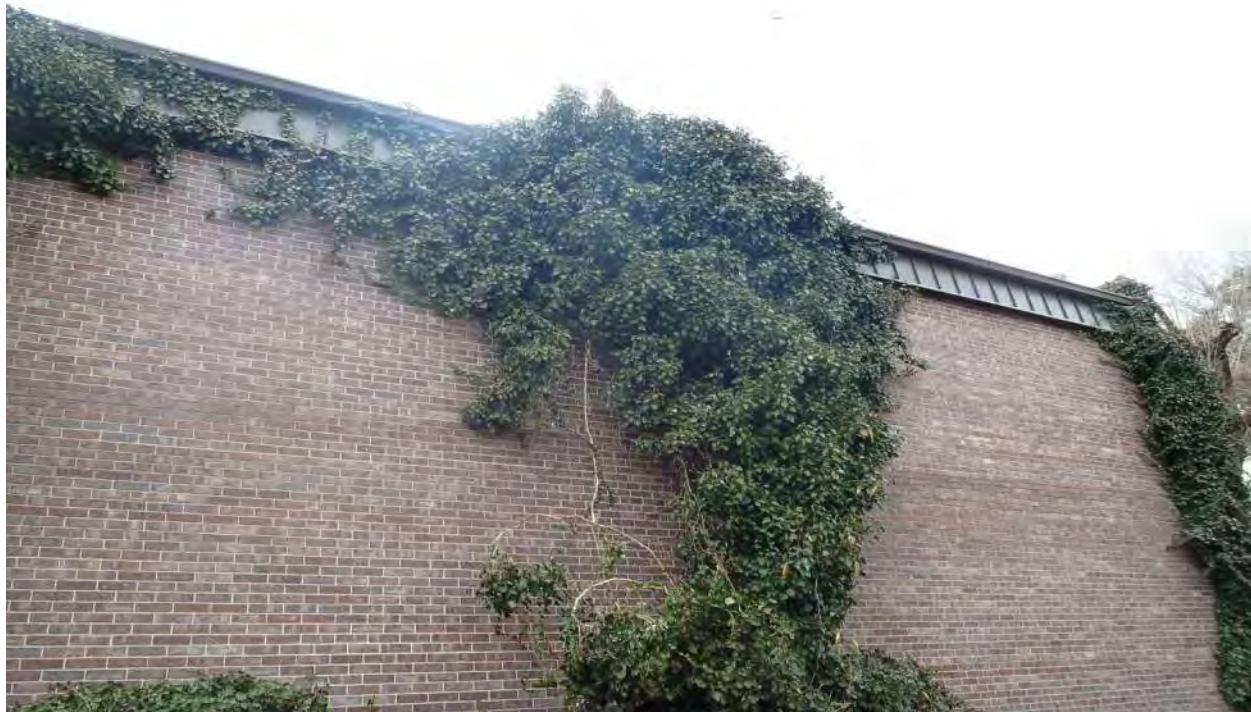
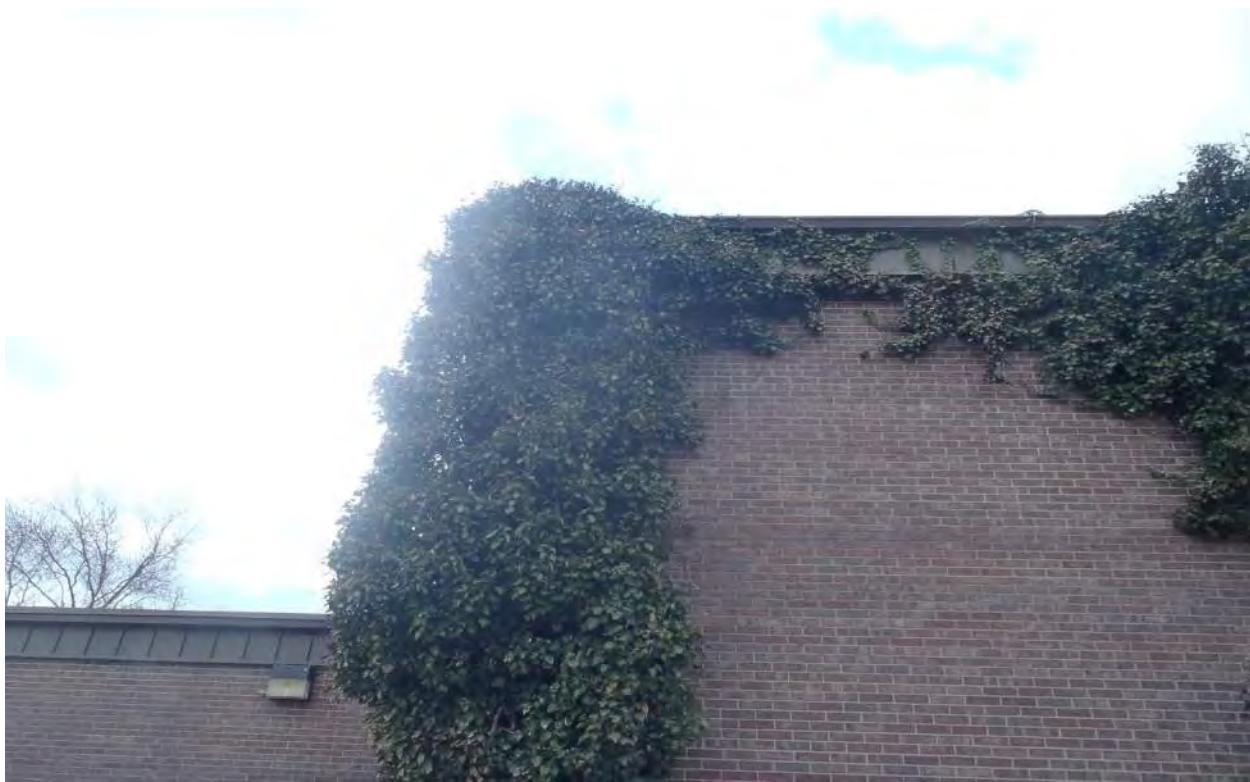
This structure is not currently in use which limited our review to exterior items only. The building appears to be a reinforced concrete structure. In review of the exterior, a major concern is vegetation growing on the exterior façade which could damage the building if not removed. Photo's #8A through 8E details these conditions in need of corrective action. Outside of this issue our only other item of concern was the usual and expected concrete cracks and spall associated with exterior concrete of this age.

Photo 8A - Vegetation Growing on Structure

Photo 8B - Vegetation Growing on Structure

Photo 8C - Vegetation Growing on Structure

Photo 8D - Vegetation Growing on Structure

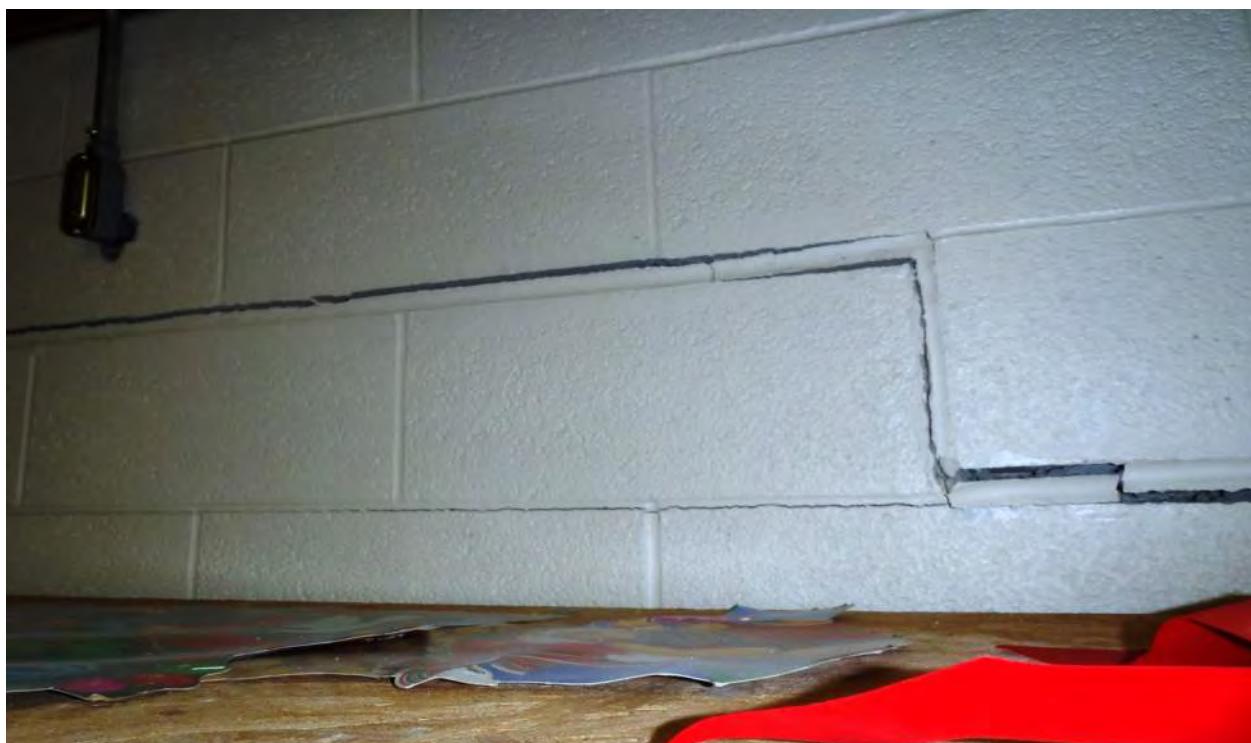
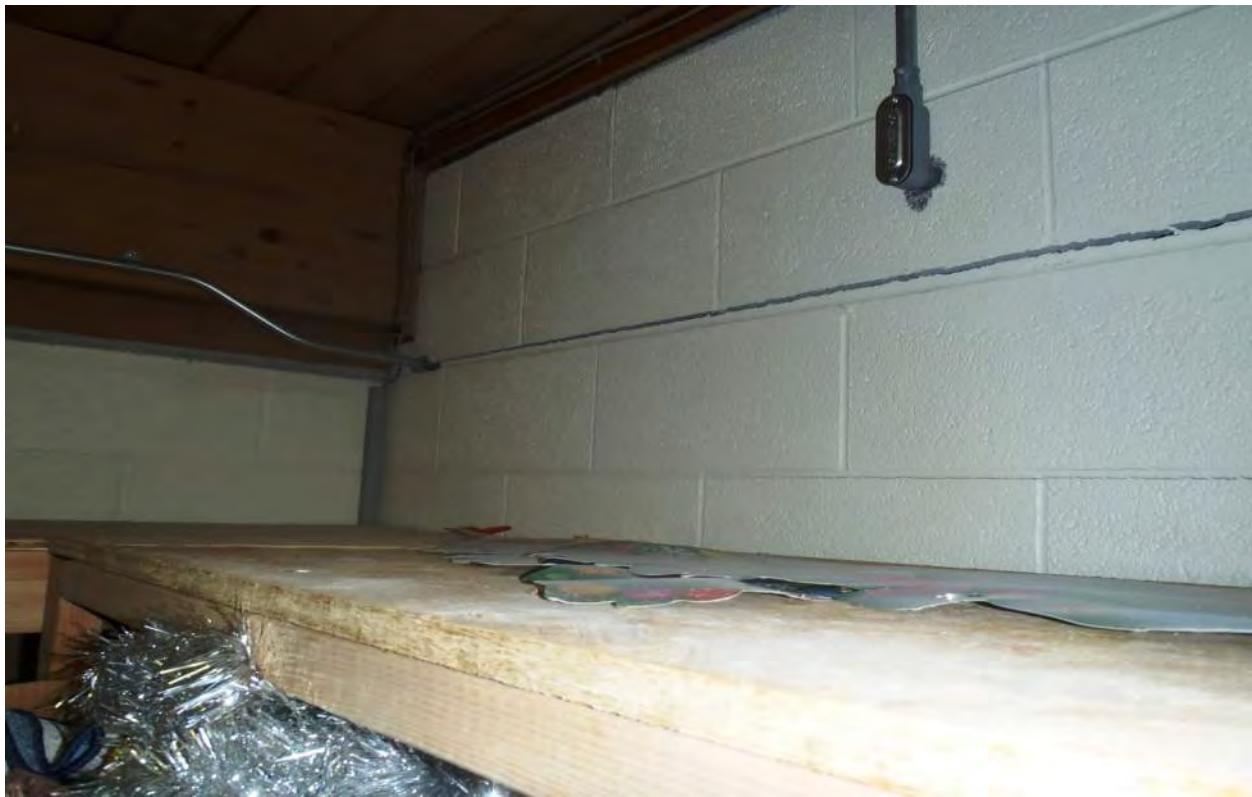
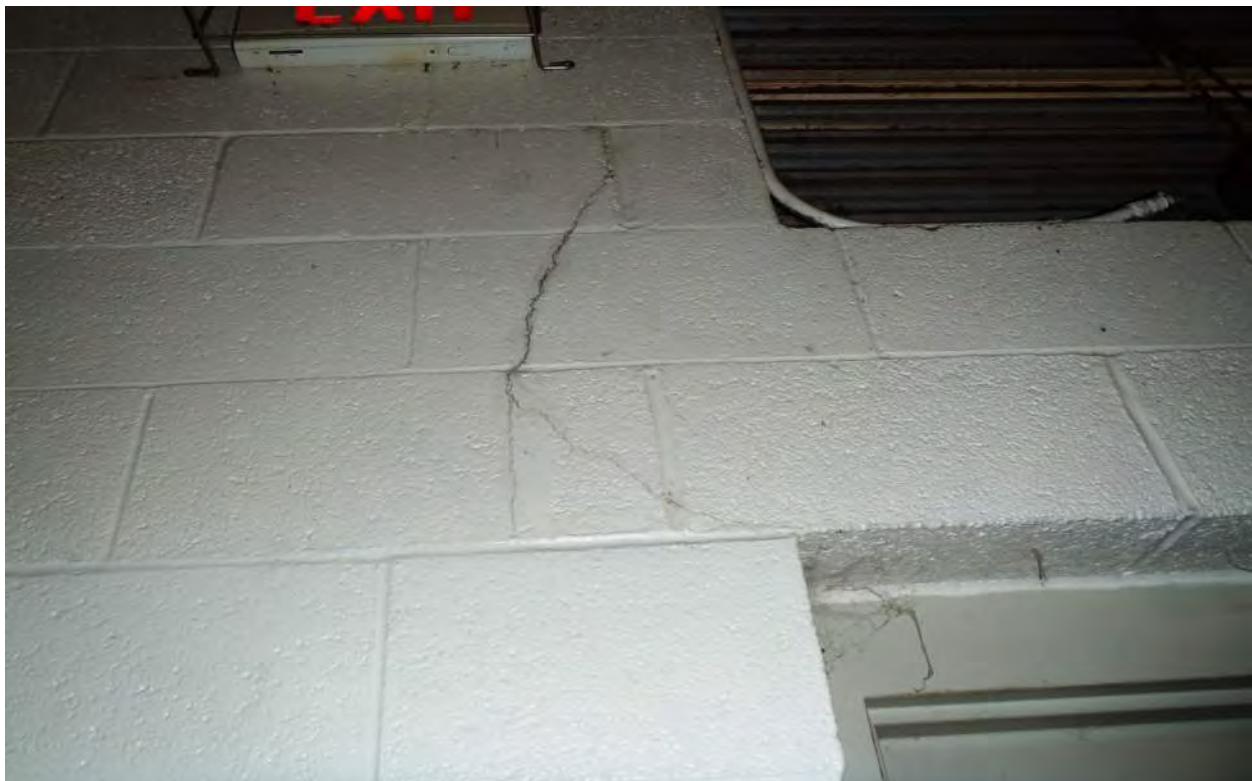
The Rice Community Center is a two level structure on a sloping site. The upper level is constructed of glulam beams atop load bearing masonry. At the west end of the structure a concrete basement structure is present. This split level condition appears to have resulted in part of the second level setting on fill. At the mechanical room located in the center north portion of the second level, significant wall cracks are present. Photo's #7A, 7B and 7C detail this condition.

Photo 7A - Significant Wall Crack at Mechanical Room Masonry

Photo 7B - Significant Wall Crack at Mechanical Room Masonry

Photo 7C - Significant Wall Crack at Mechanical Room Masonry

These walls which do not appear to be load bearing are setting on a slab on grade which has settled significantly. The repair at this area is to underpin the masonry walls and tuckpoint at damaged joints in the wall. Photo #7D details the downspout condition at this area which is in need of corrective action. This may be a potential source of the interim slab settlement observed. Some concrete cracking and spalling was also observed at the corners of the west lower level structure. Photo's #7E and 7F detail some of these concrete areas in need of repair.

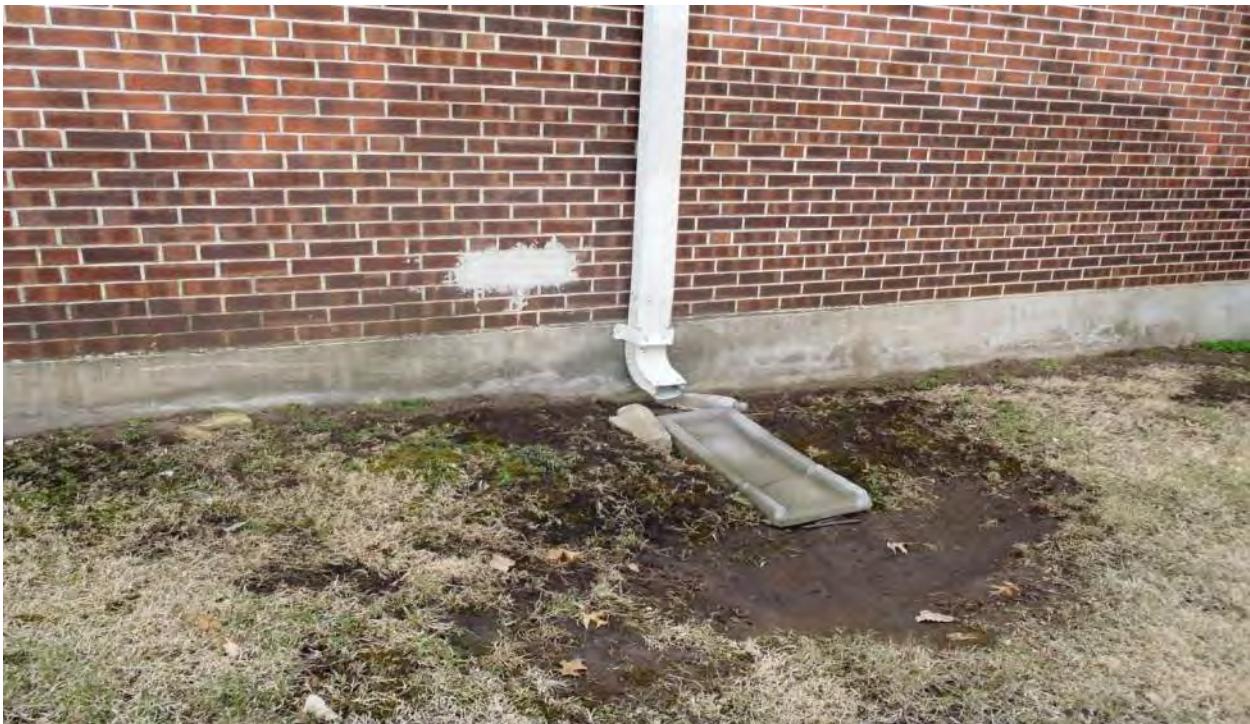
Photo 7D - Downspout Condition at North Elevation, Second Floor

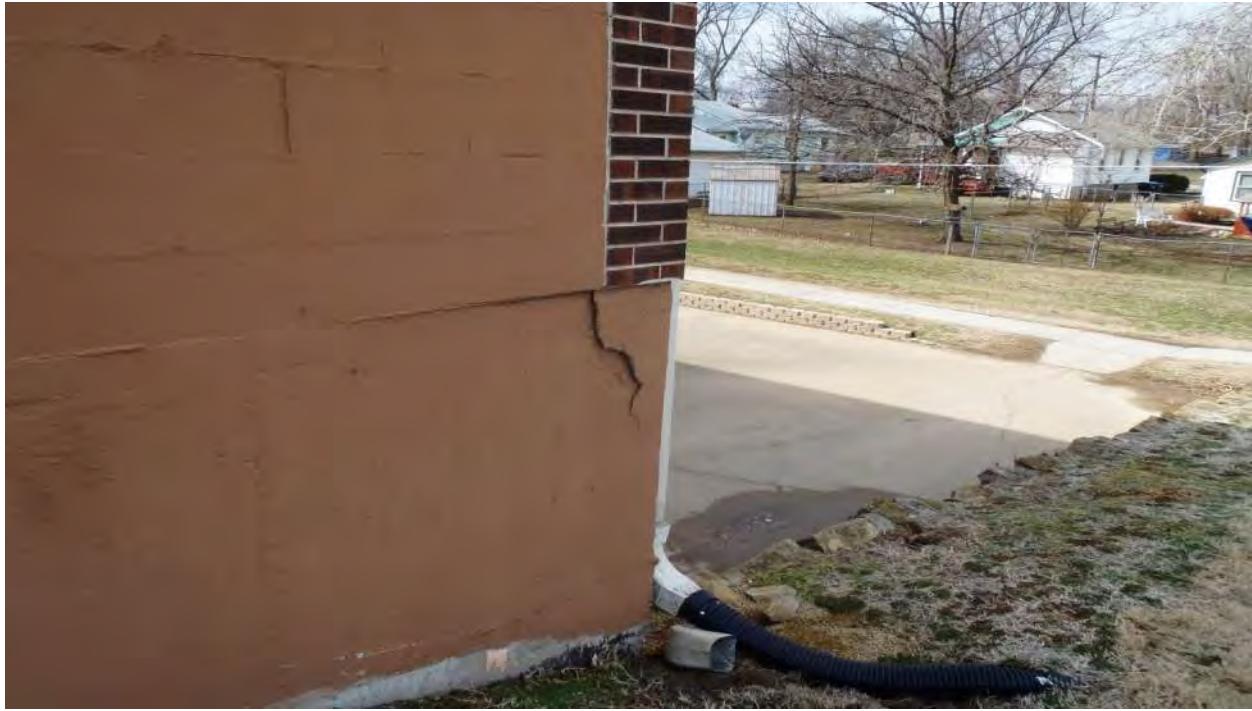
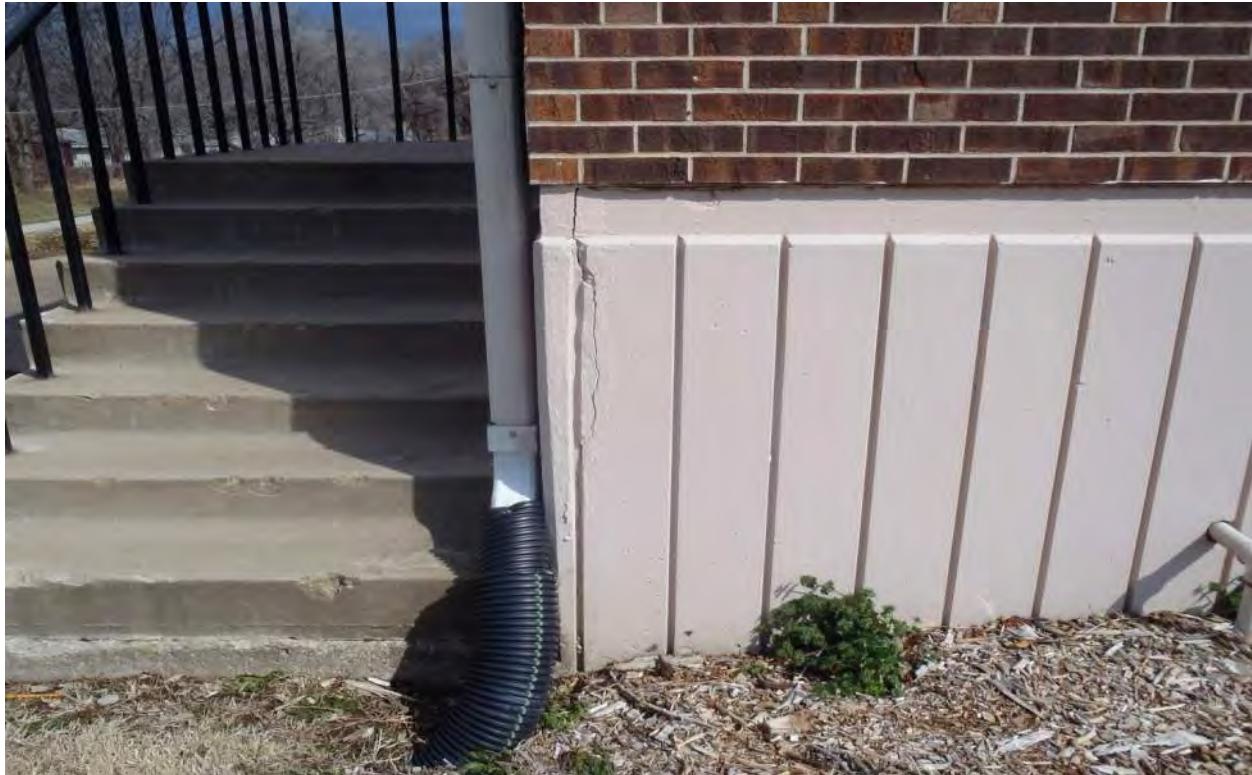
Photo 7E - Concrete Crack / Spall at Lower Level

Photo 7F - Concrete Crack / Spall at Lower Level

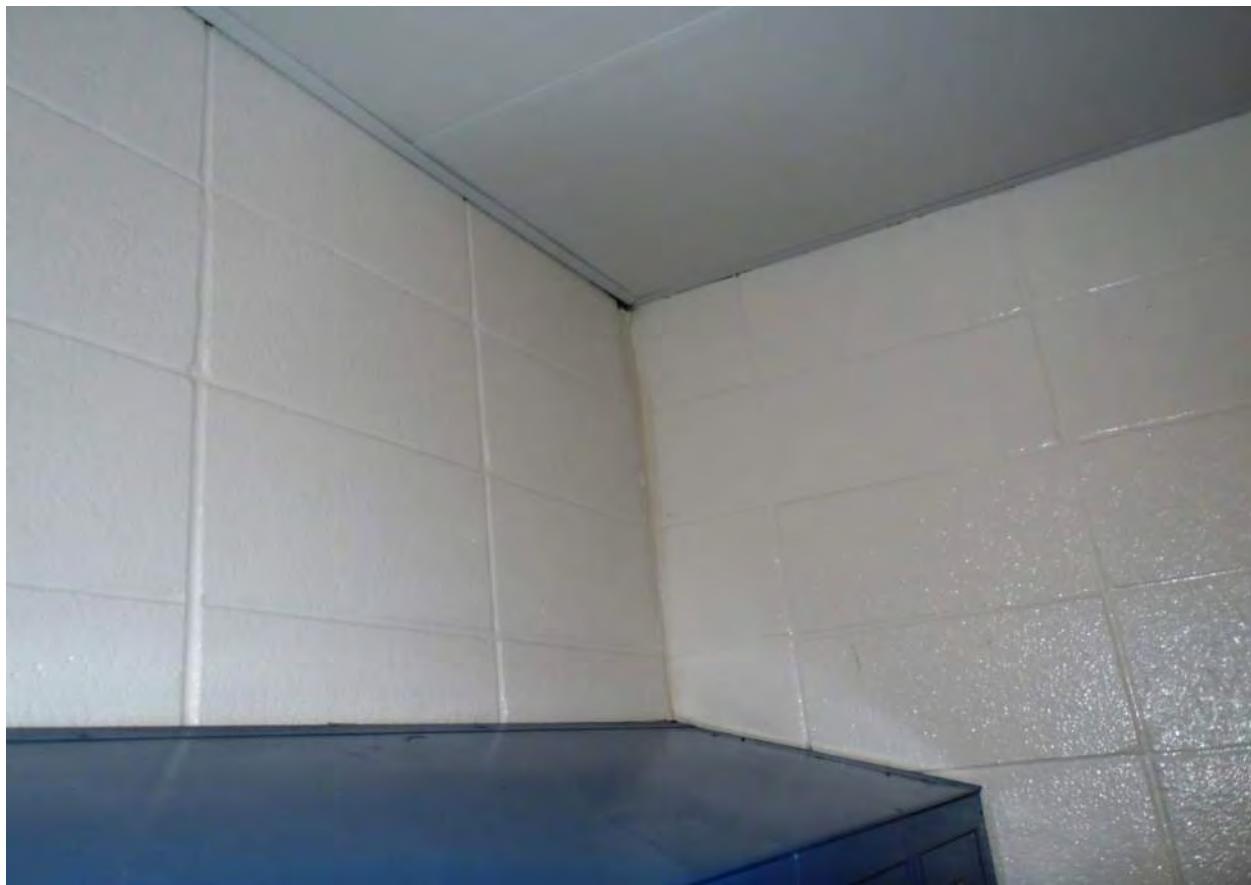
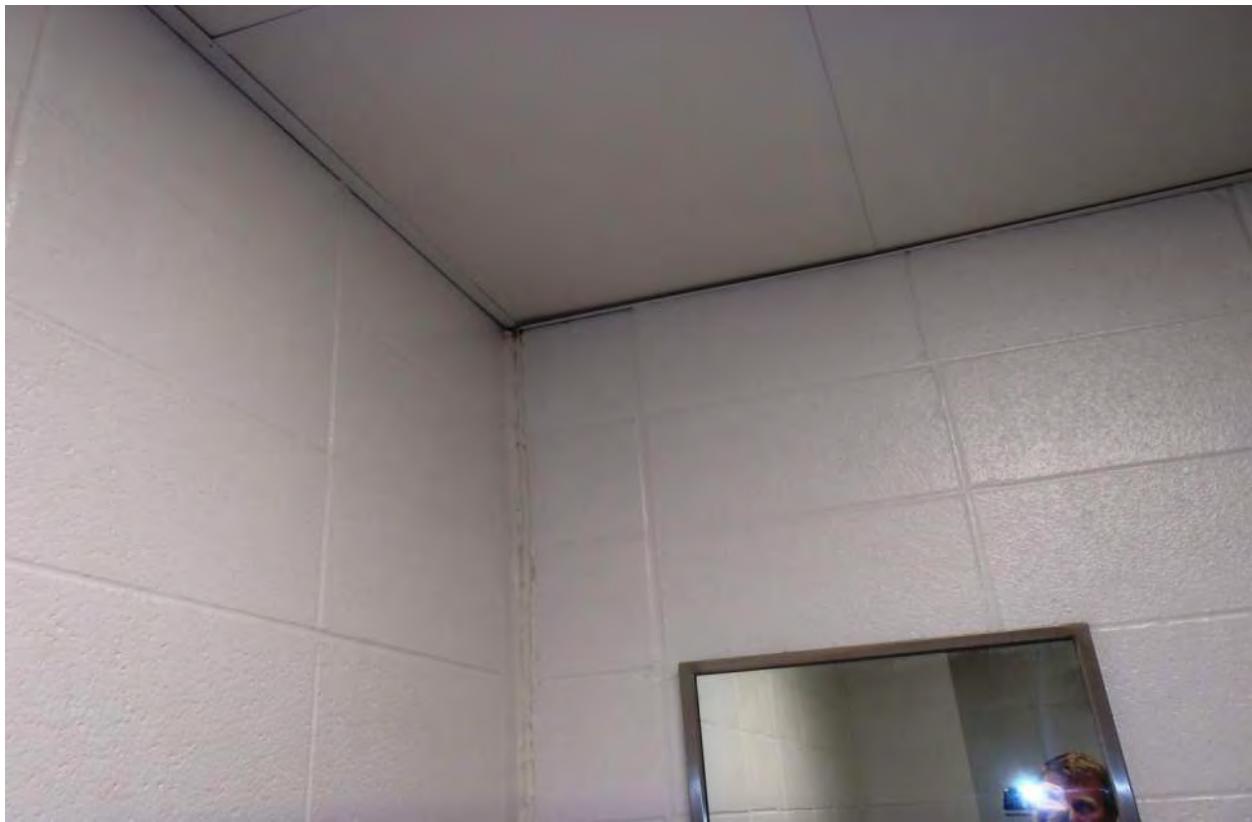
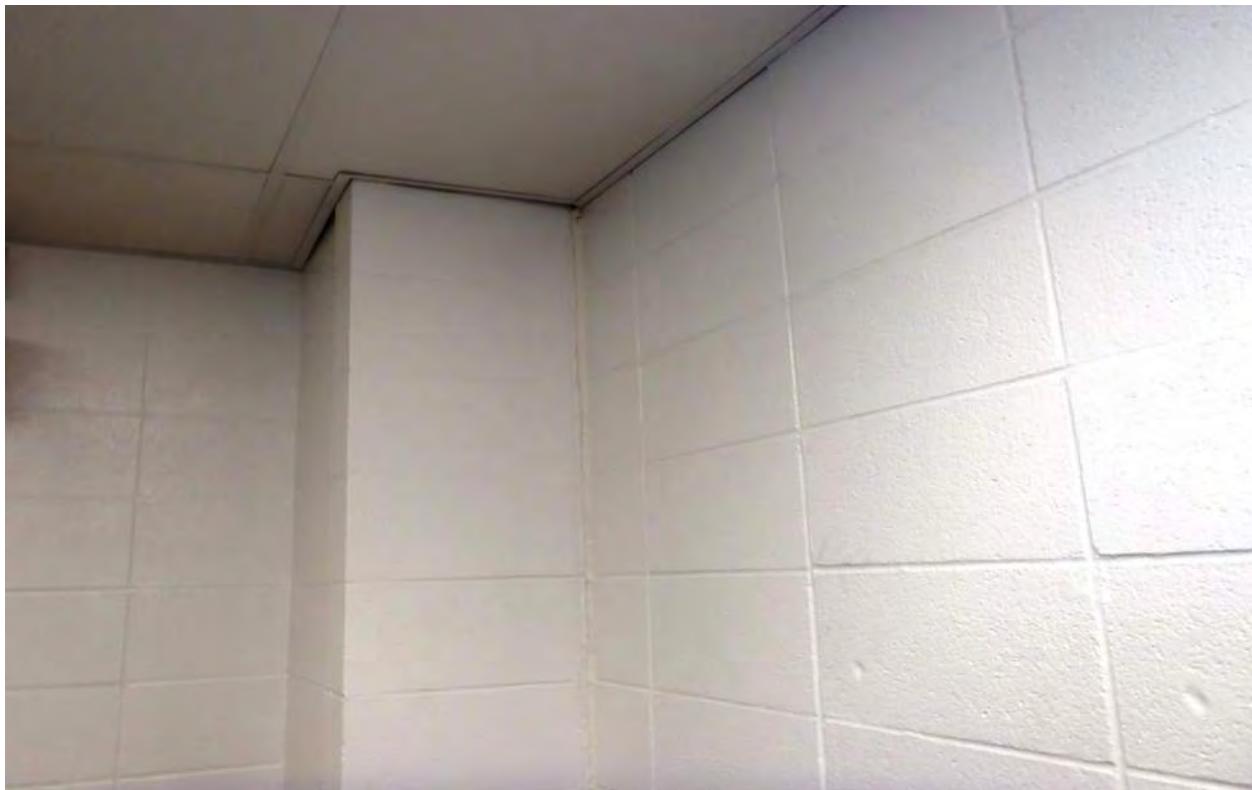
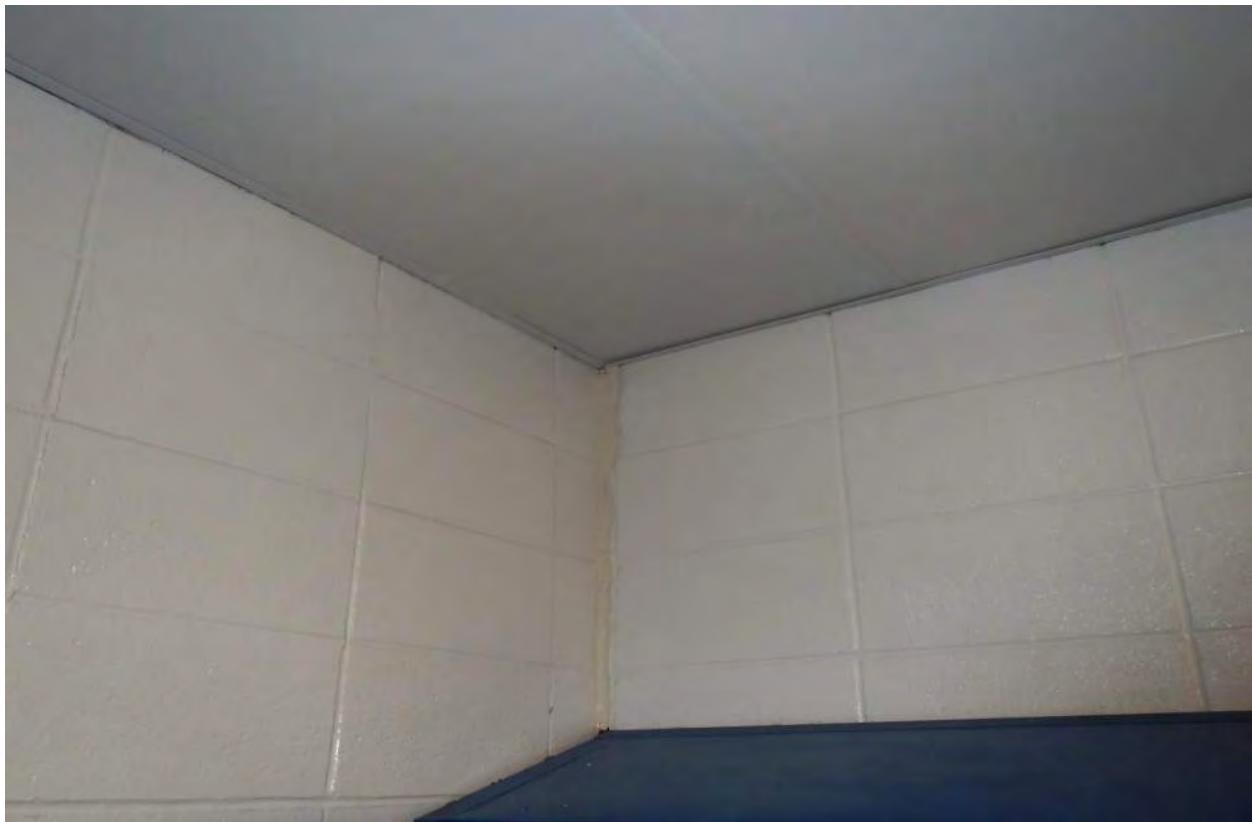
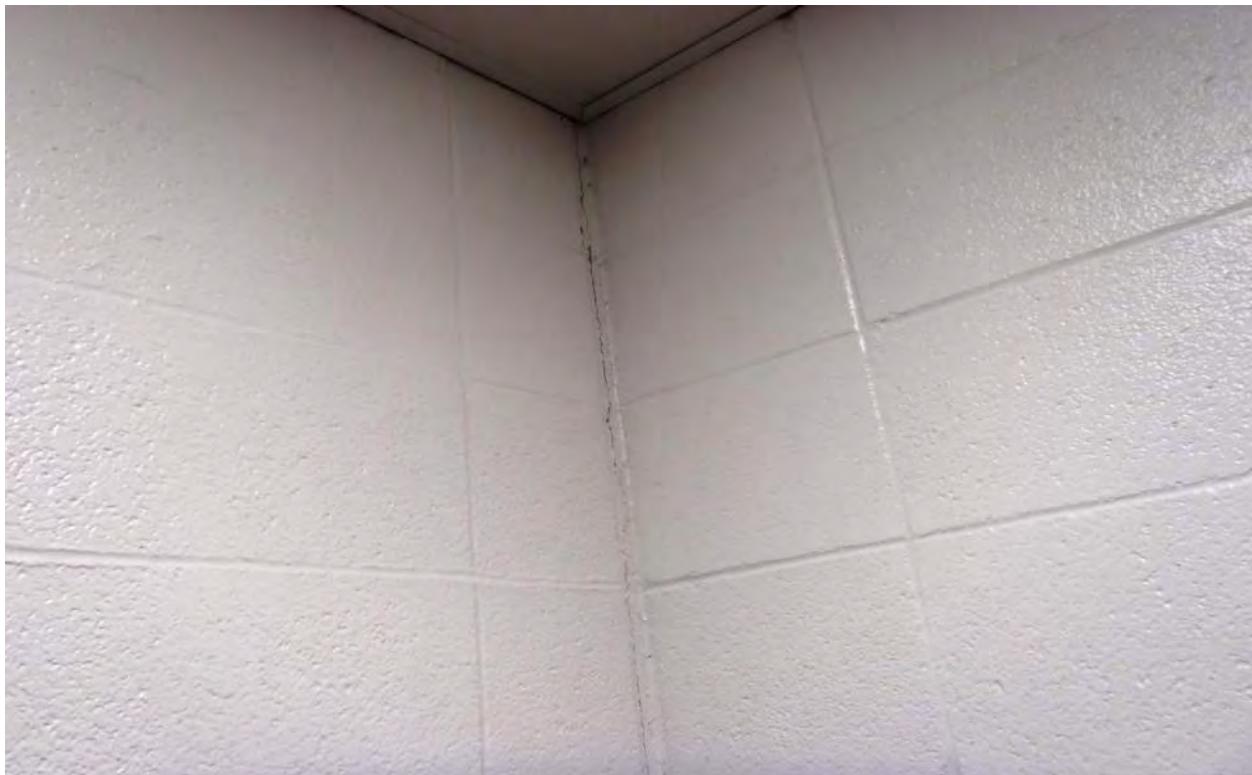
Hillcrest Community Center is a single level building. The structural frame is a combination of a steel deck atop long span bar joists with exterior load bearing masonry wall. The area west of the gymnasium is framed with glulam beam and load bearing masonry walls. East of the gymnasium a reinforced concrete racket ball structure is present. Overall this building does have some signs of foundation settlement present; however, the level of settlement is nowhere near the settlement issue on the Rice Community Center. Photo's #9A through 9E detail some example of settlement observed at the locker room.

Photo 9A - Masonry Wall Cracking at Locker Room

Photo 9B - Masonry Wall Cracking at Locker Room

Photo 9C - Masonry Wall Cracking at Locker Room

Photo 9D - Masonry Wall Cracking at Locker Room

Photo 9E - Masonry Wall Cracking at Locker Room

These repairs are not at a level where foundation underpinning would be recommended. The cosmetic repair of these cracks knowing this repair may be needed in the future is the most cost effective repair at this time.

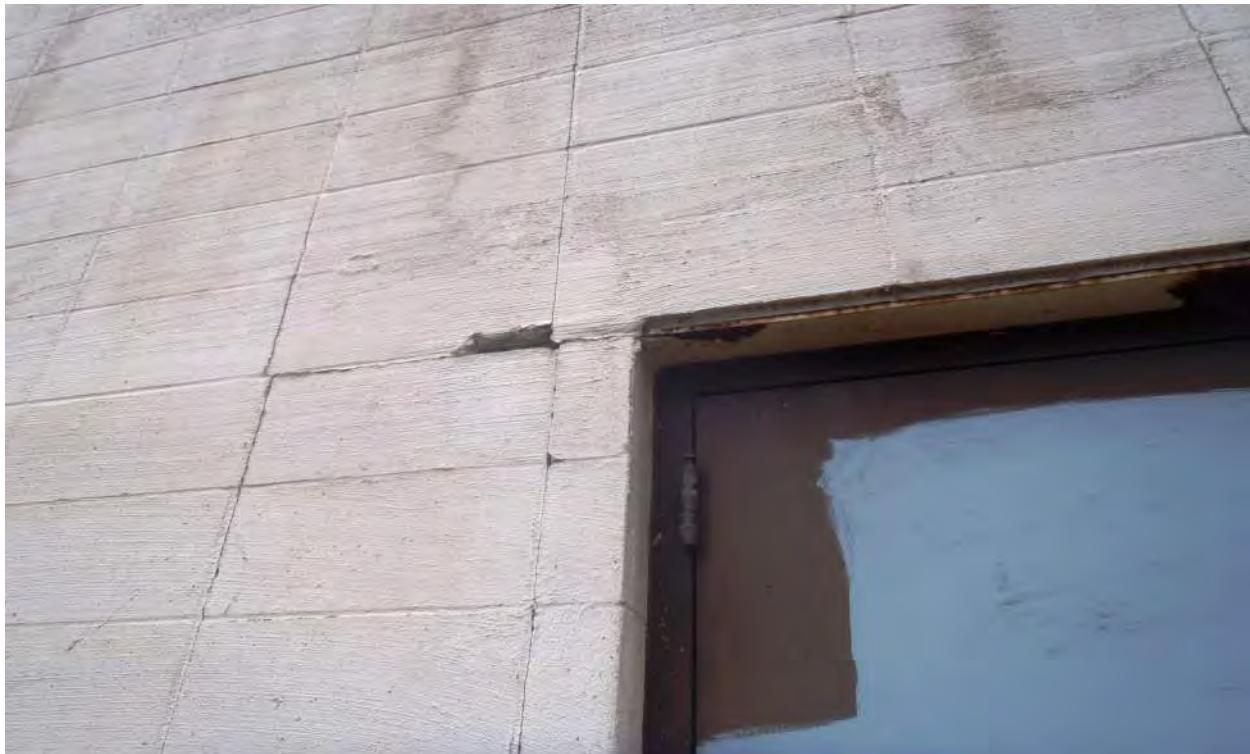
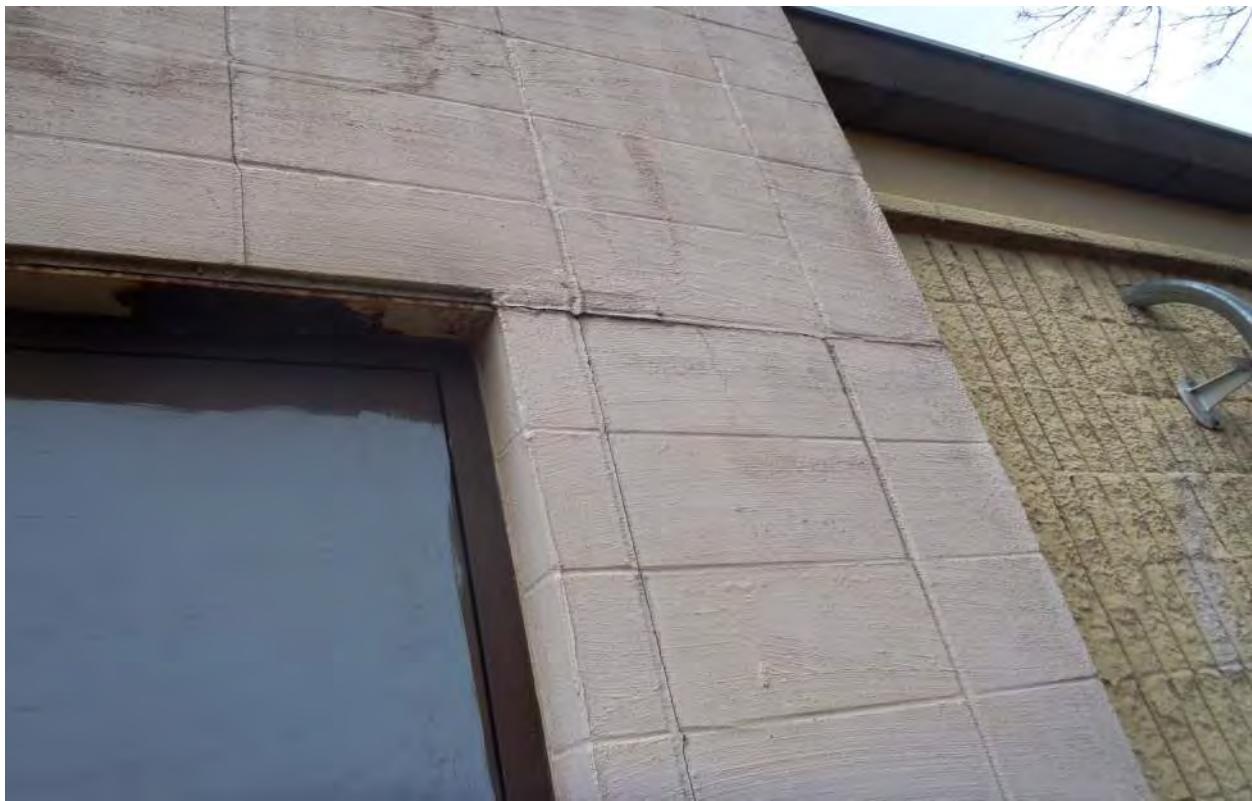
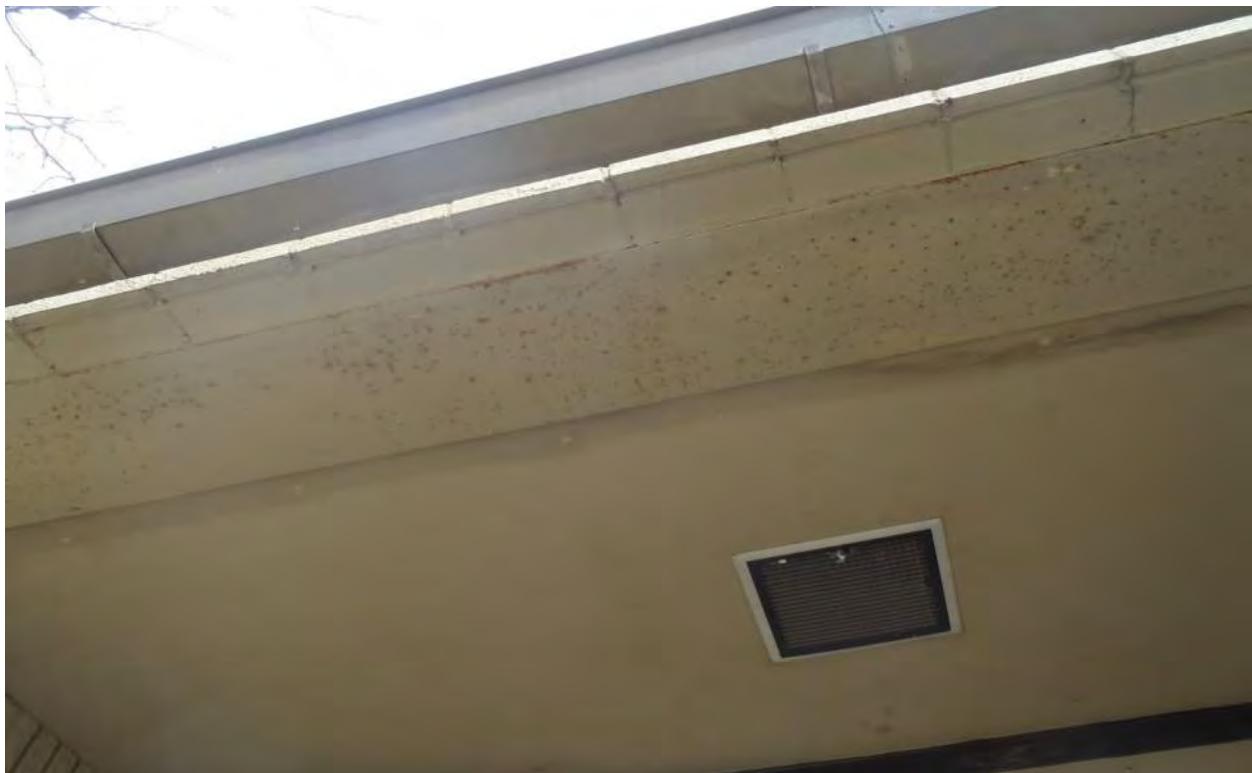
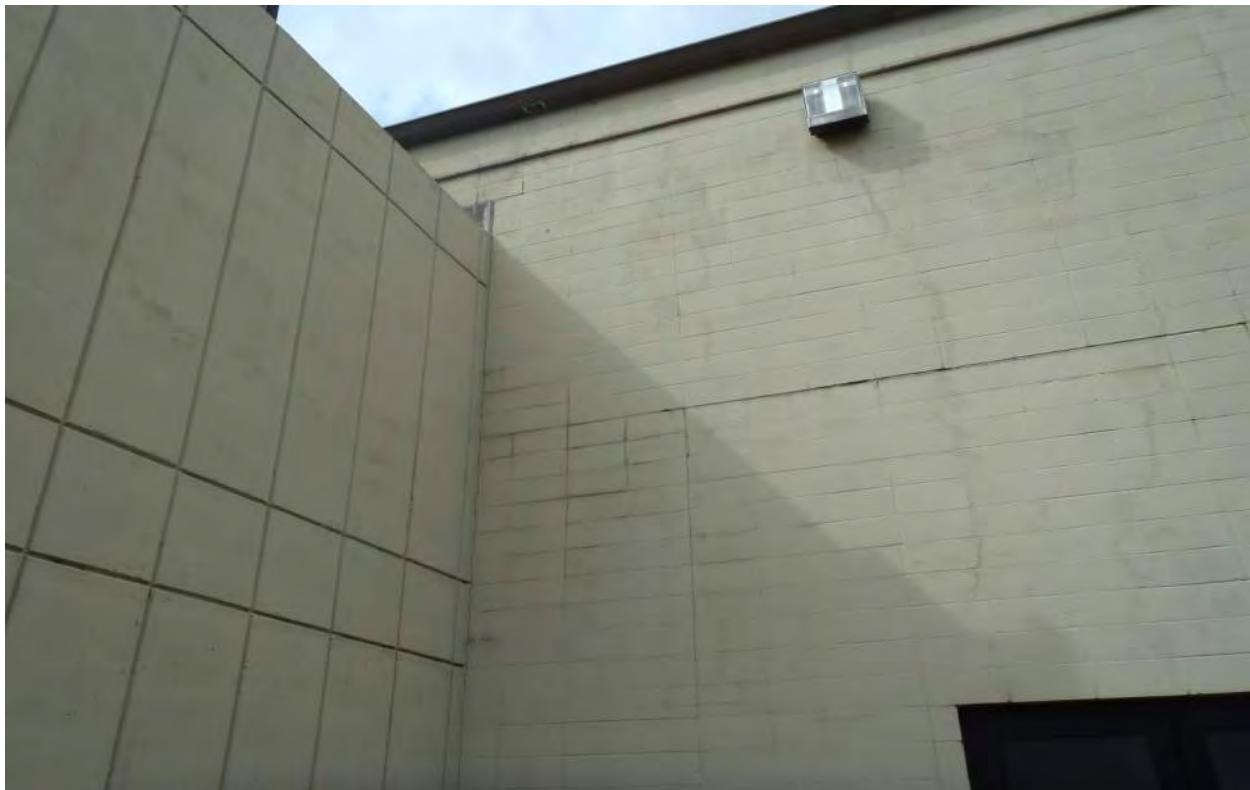
In addition to this area some minor foundation settlement was observed at the west lobby area. These cracks were similar in nature to the locker room cracking observed. The exterior masonry some masonry cracks in need of repair were present. Photo's #9F through 9I details these areas in need of repair.

Photo 9F - Exterior Masonry Cracking

Photo 9G - Exterior Masonry Cracking

Photo 9H - Exterior Masonry Cracking

Photo 9I - Exterior Masonry Cracking

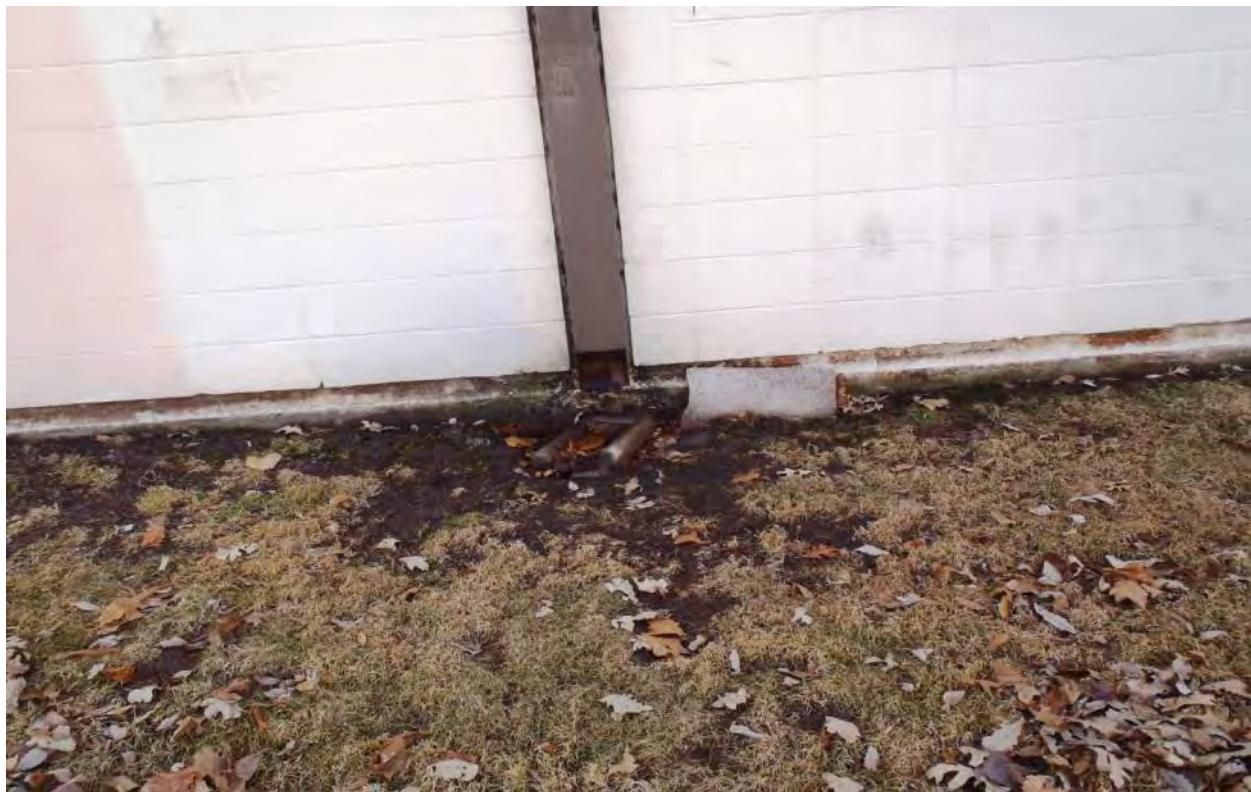
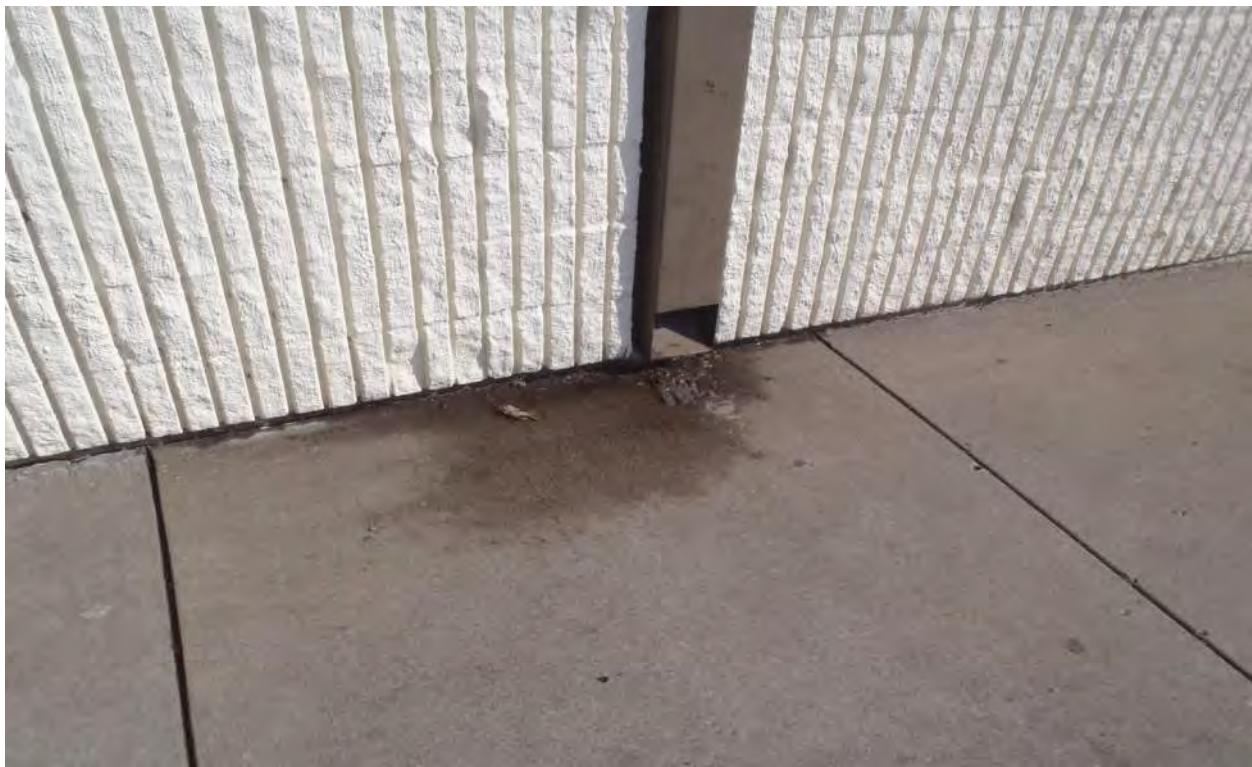
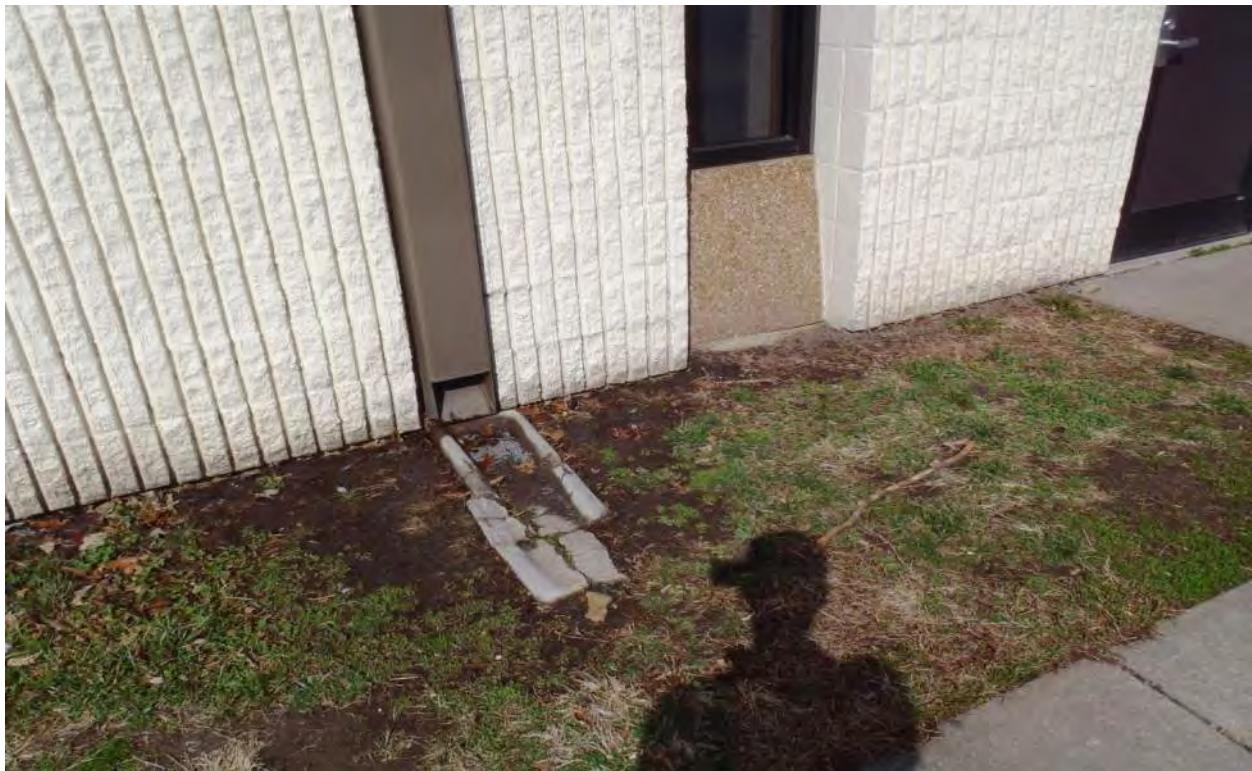
The Oakland Community Center was constructed in 1977. The building construction consists of a structural steel gymnasium structure with a glulam frame entry area south of the gymnasium. A concrete structure is present under the stage area at the gymnasium. Overall, this building is in fairly good structural condition for a 37 year old building. Our only comments on this building are the exterior site drainage and the condition of the exterior concrete on the project. Photo's #6A, 6B, and 6C show downspouts adjacent to the building.

Photo 6A - Downspout Adjacent to Building

Photo 6B - Downspout Adjacent to Building

Photo 6C - Downspout Adjacent to Building
