SHAWNEE COUNTY
PARKS AND RECREATION

**RECREATION
— CENTER —
ASSESSMENTS**

Topeka, Kansas

MAY 2014

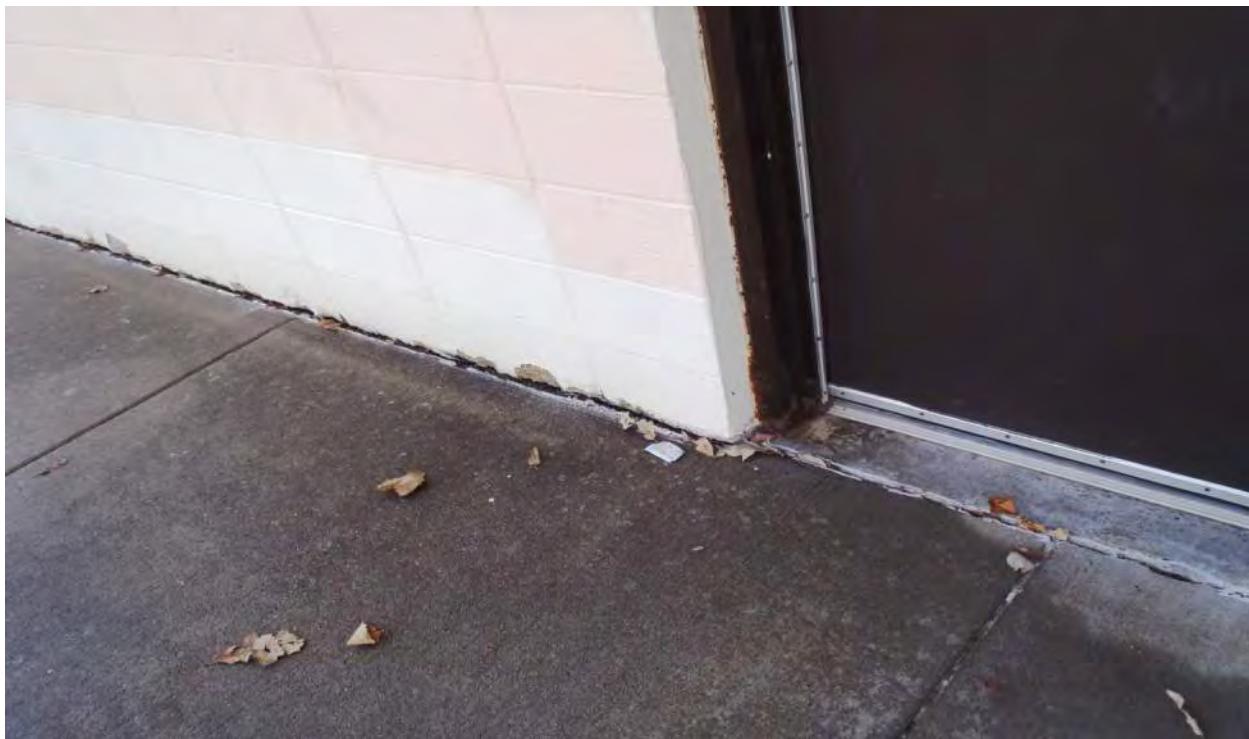
Photo 6D shows some exterior masonry spalling at the base of an exterior masonry wall.

Photo 6D - Exterior Concrete Spalling

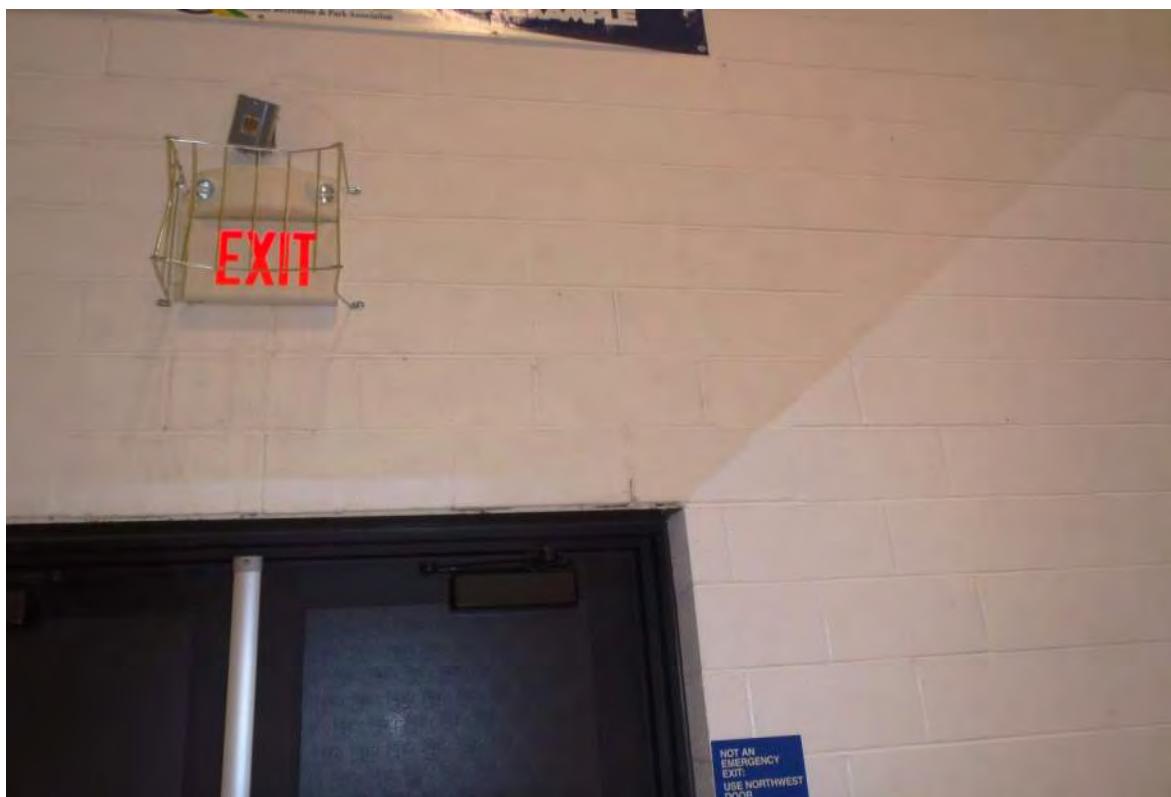
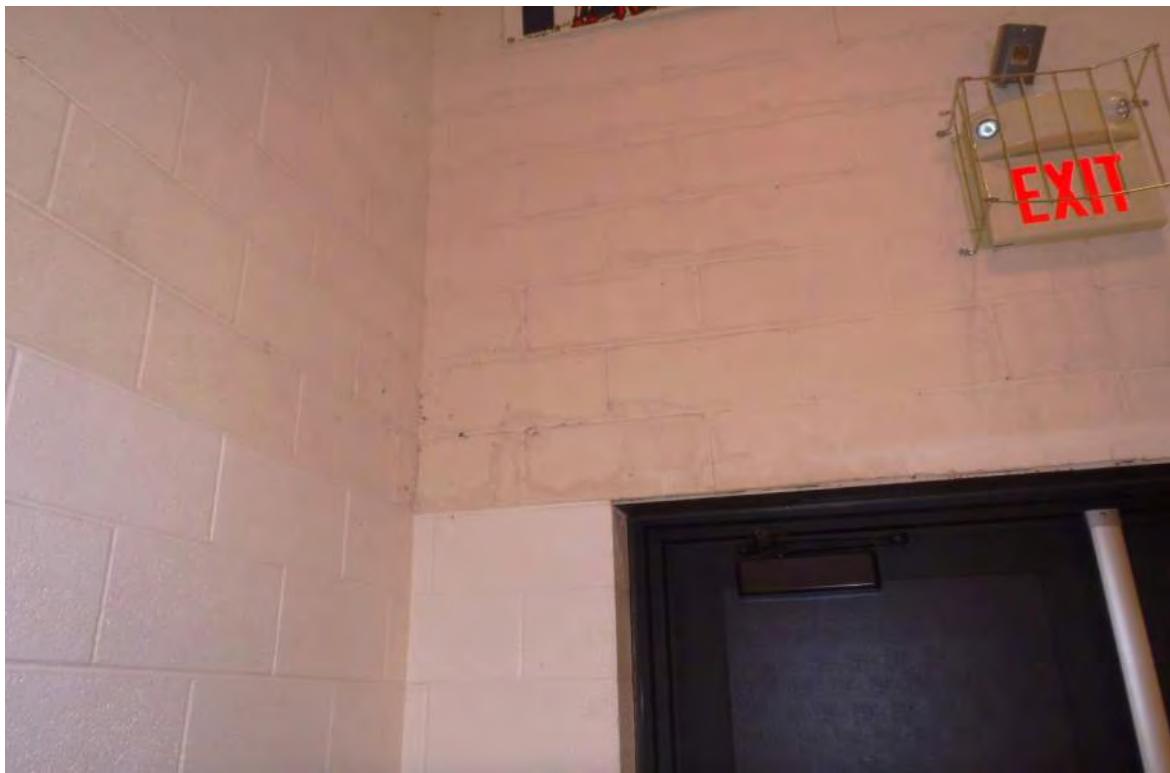
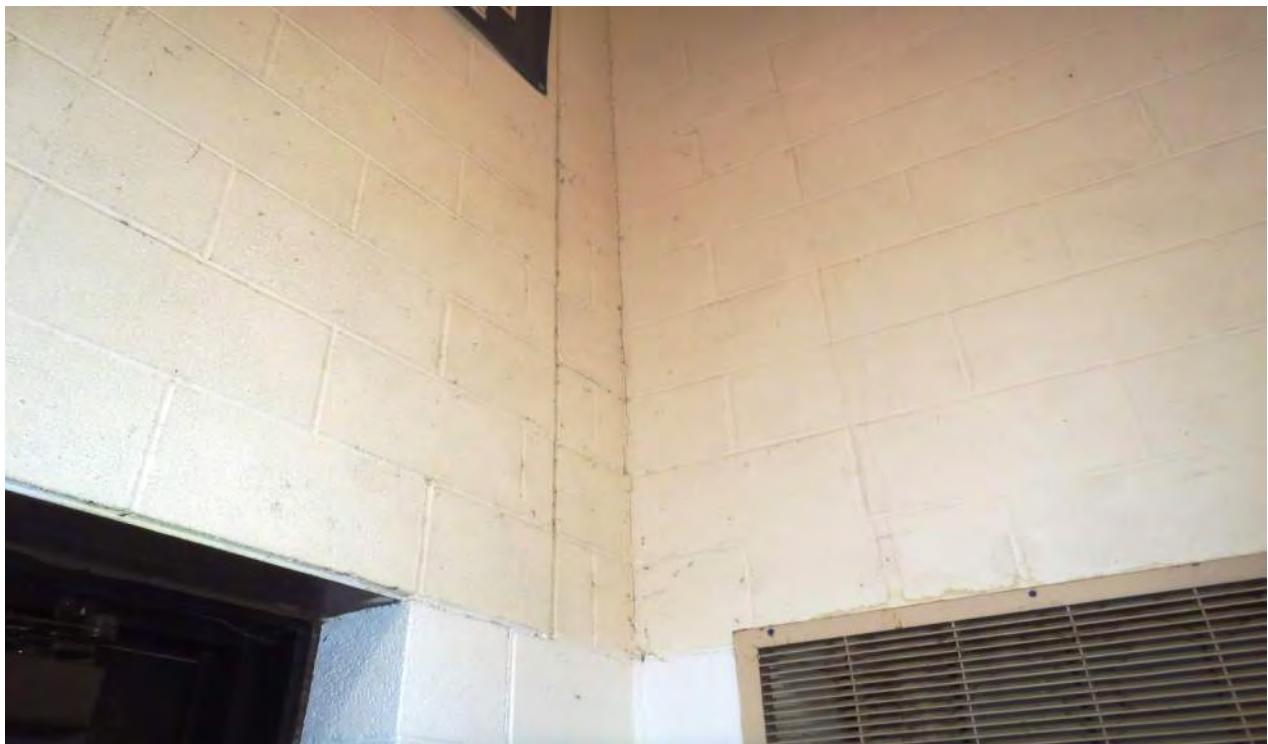
The Central Park Community Center appears to be the largest community center out of the 9 buildings. This structure was constructed in 1977. The building construction is a combination of long span steel bar joists with exterior masonry bearing walls in combination with reinforced concrete basement structure at the south end of the building. Based upon consideration of the building's size and age, it appears to be in good condition. At the gym area, several relatively minor settlement cracks were observed in the perimeter masonry gymnasium walls. Photo's #3A through 3C outlines this condition.

Photo 3A - Masonry Cracking at Interior Gymnasium Wall

Photo 3B - Masonry Cracking at Interior Gymnasium Wall

Photo 3C - Masonry Cracking at Interior Gymnasium Wall

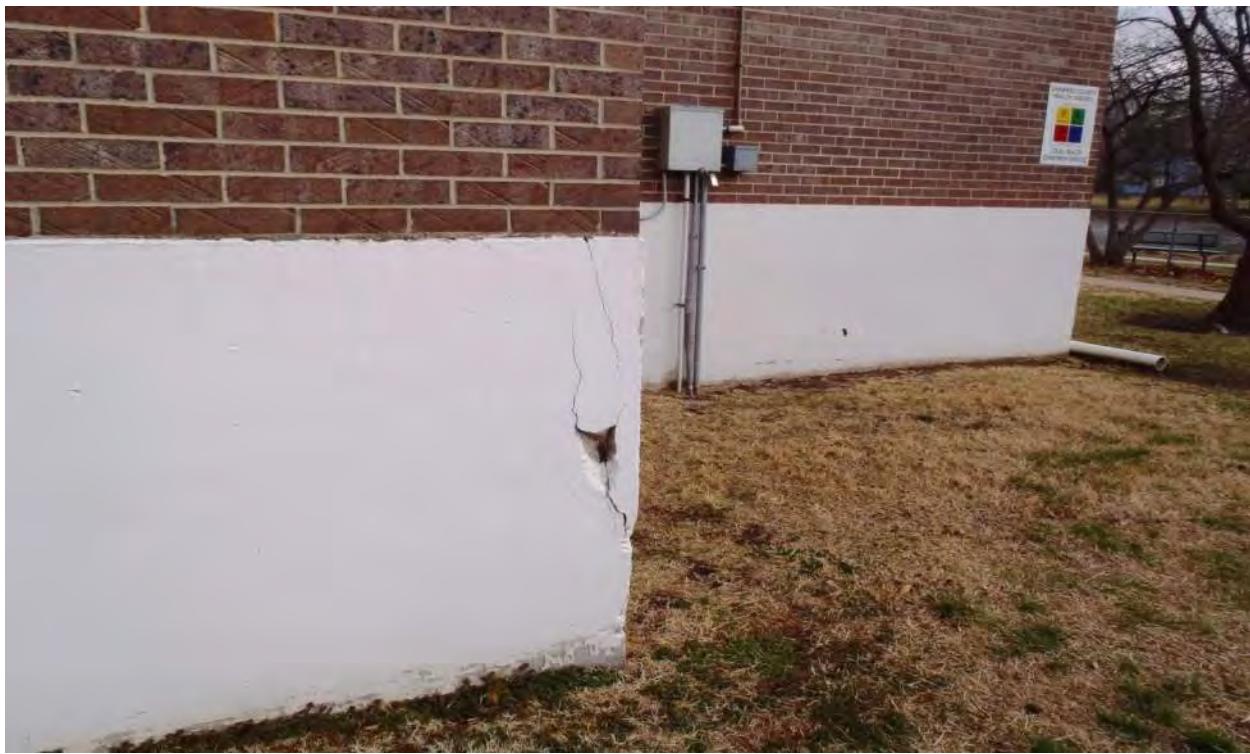
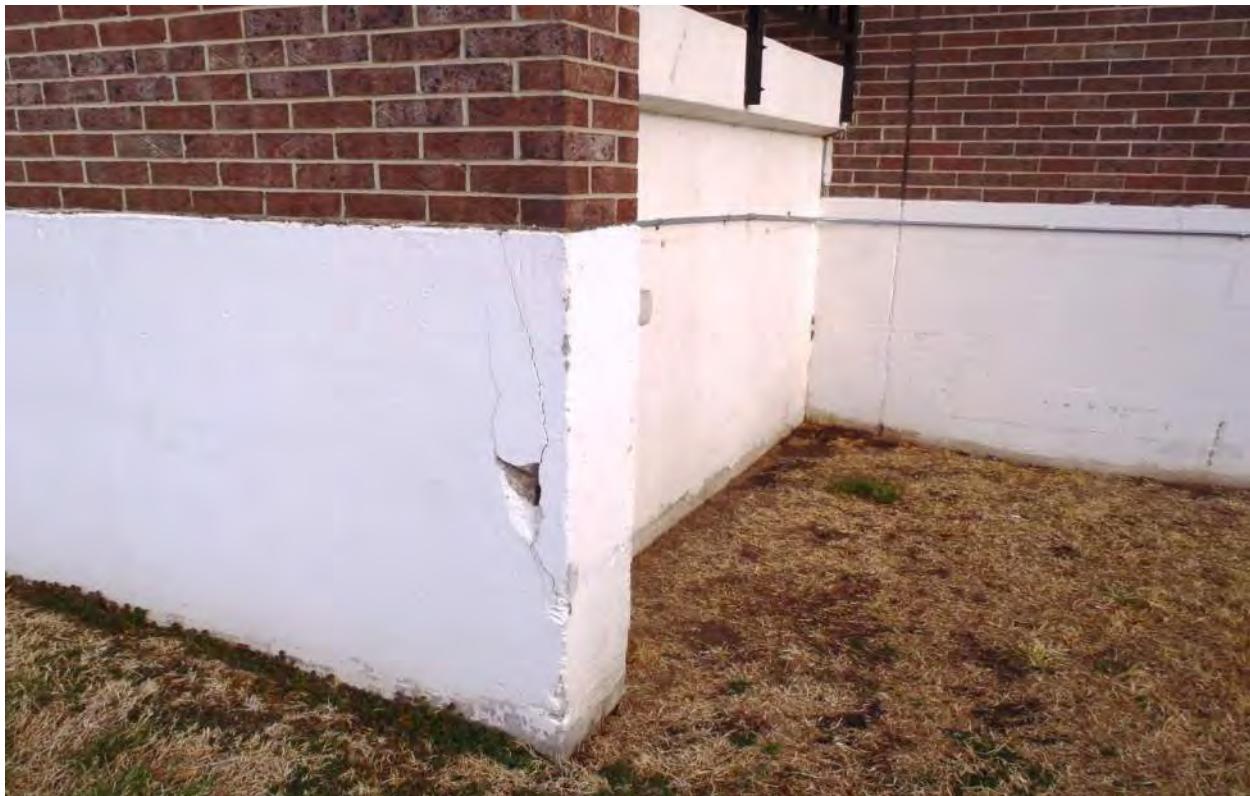
At the exterior exposed concrete structure at the south end of the building, some concrete spalling in need of repair was observed. Photo's #3D and 3E outline this condition.

Photo 3D - Concrete Spalling at Exterior Concrete Structure

Photo 3E - Concrete Spalling at Exterior Concrete Structure

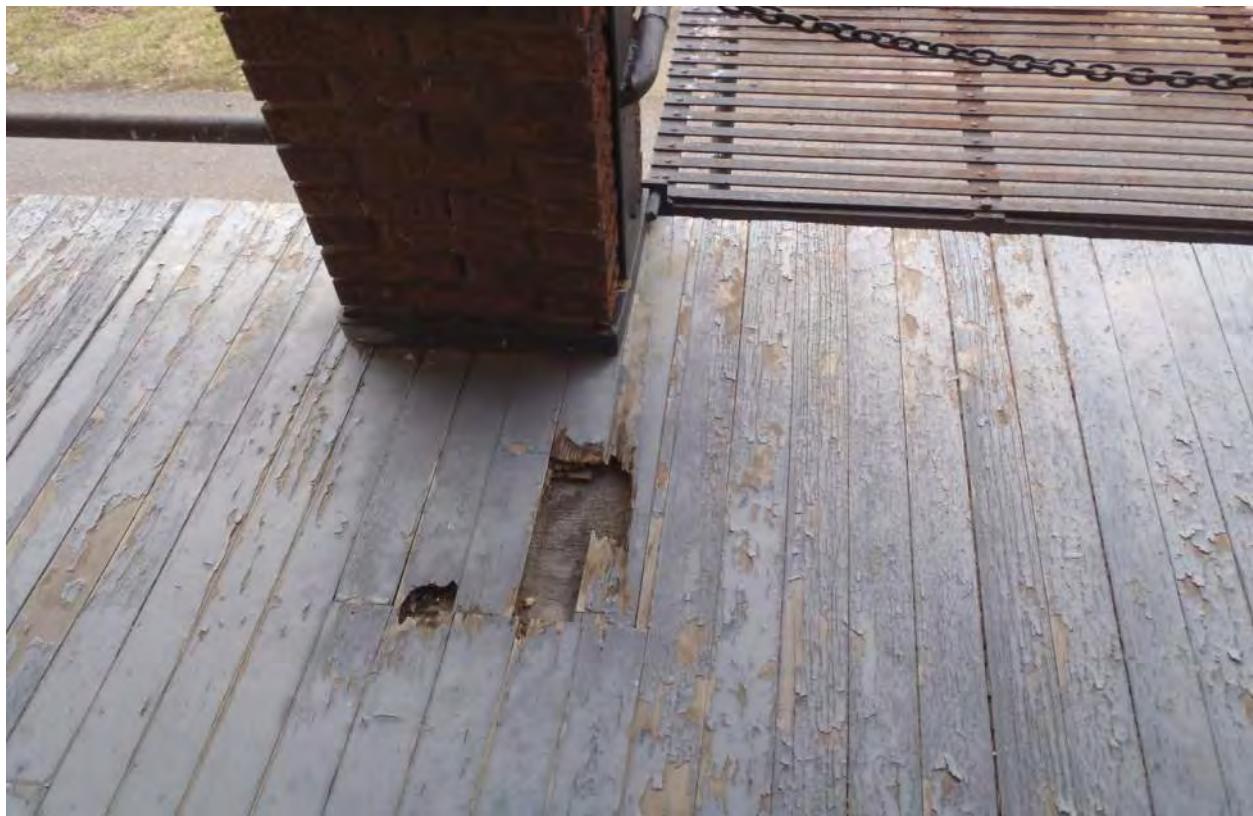
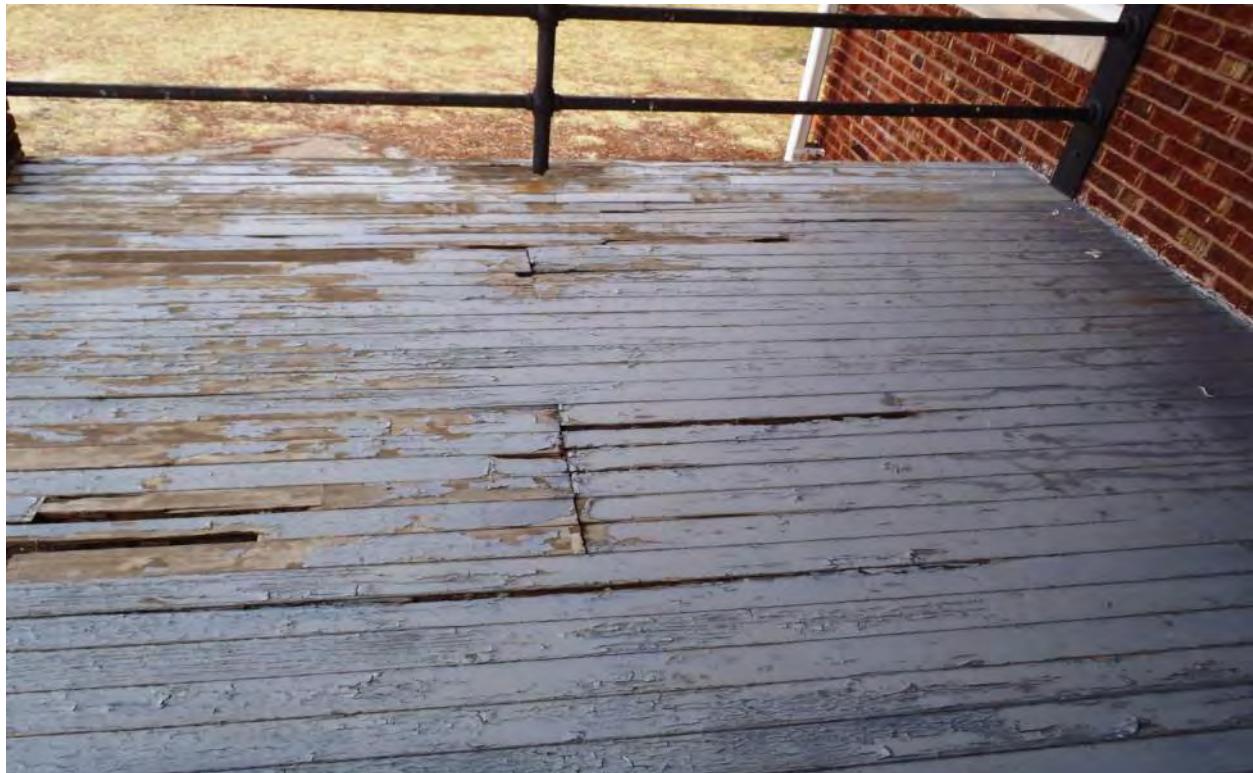
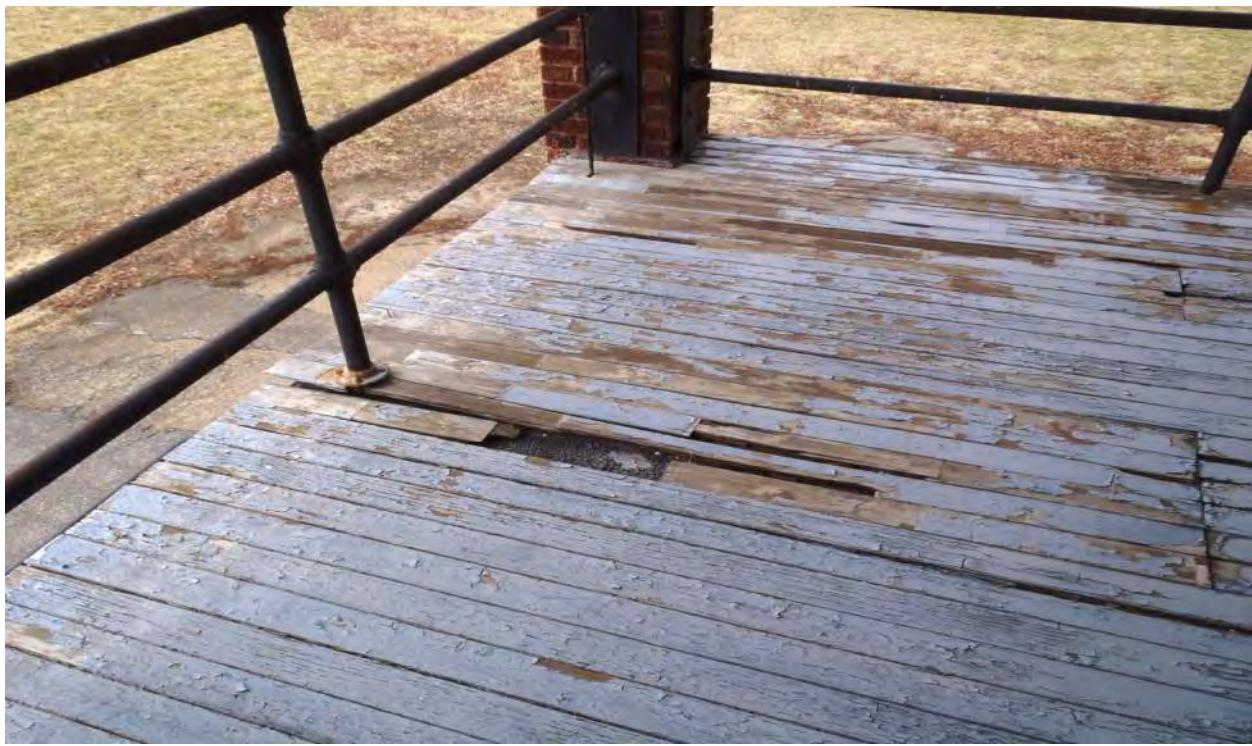
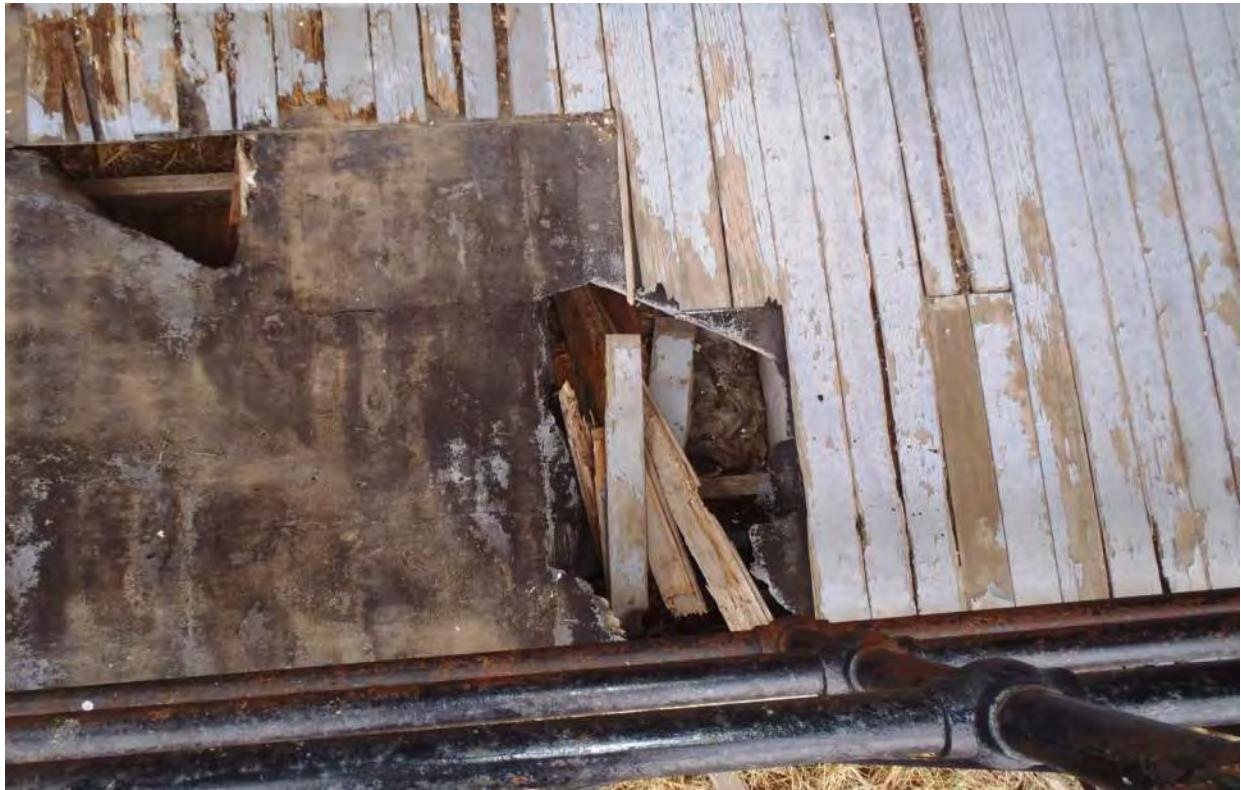
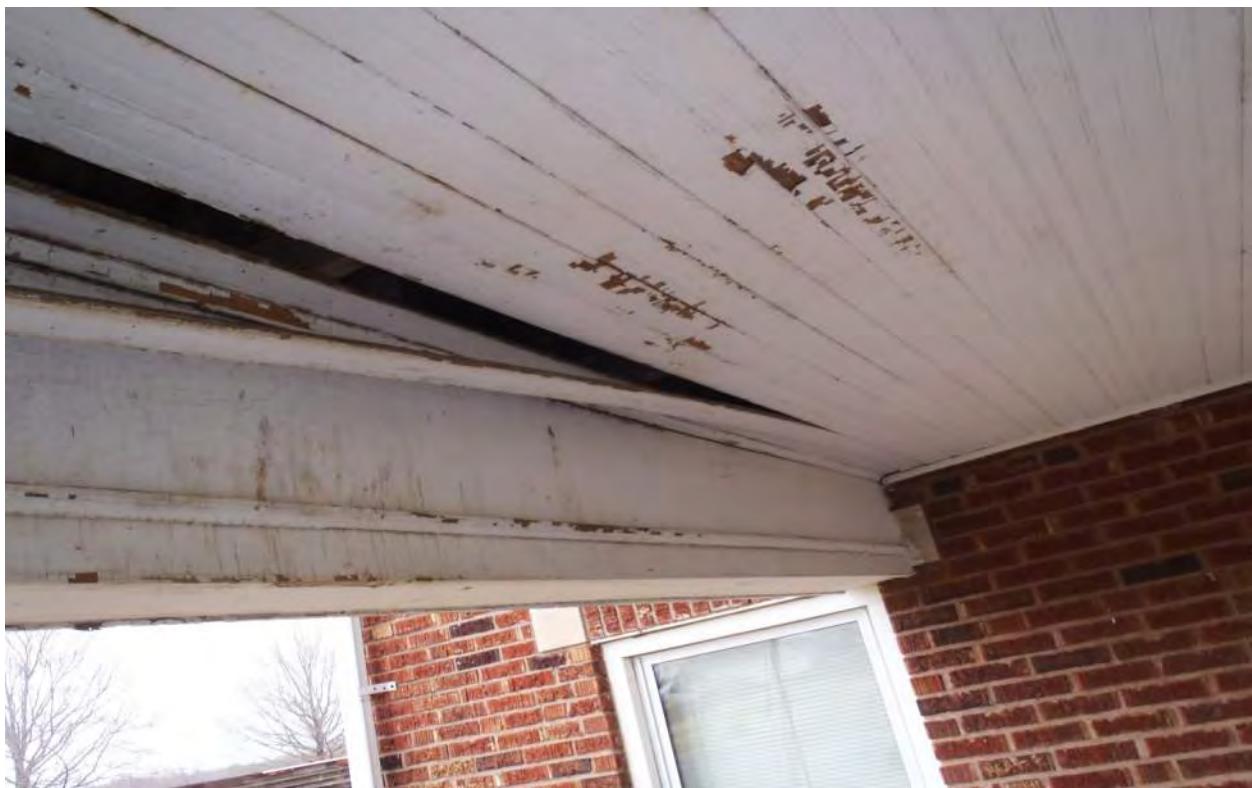
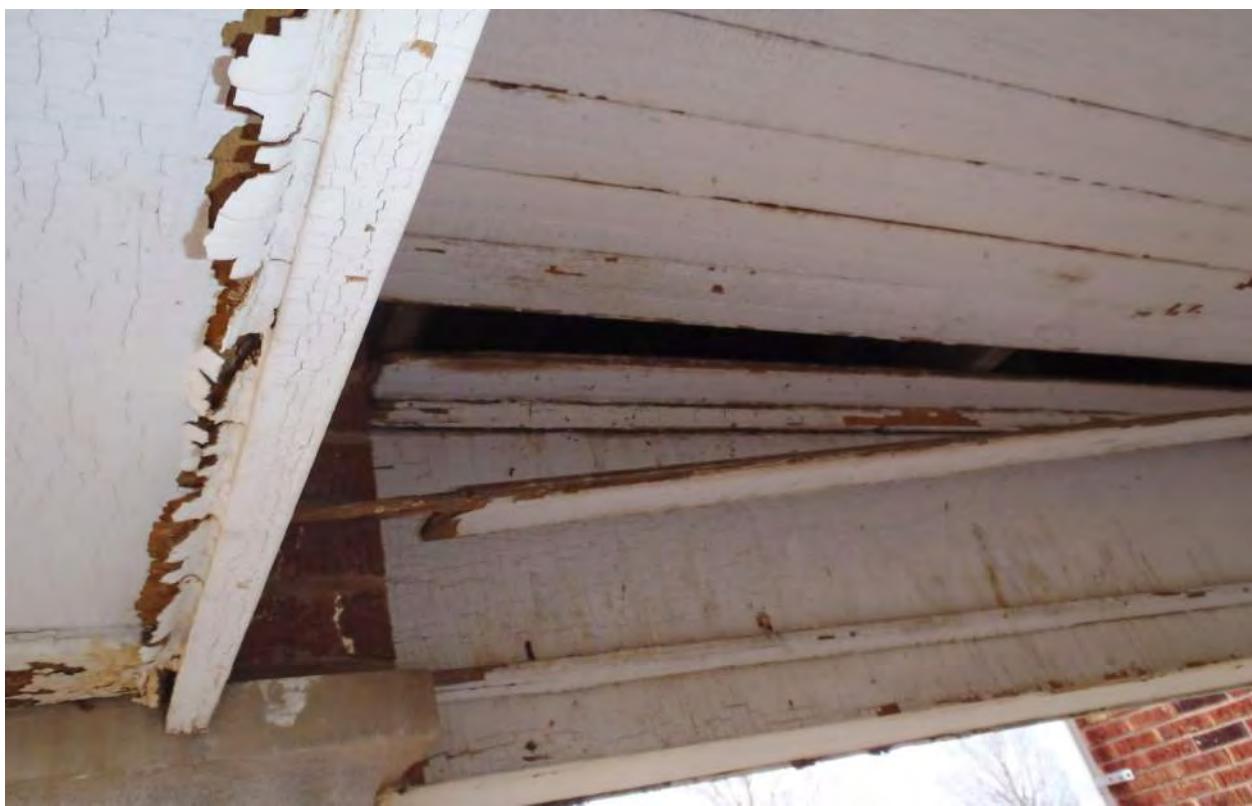
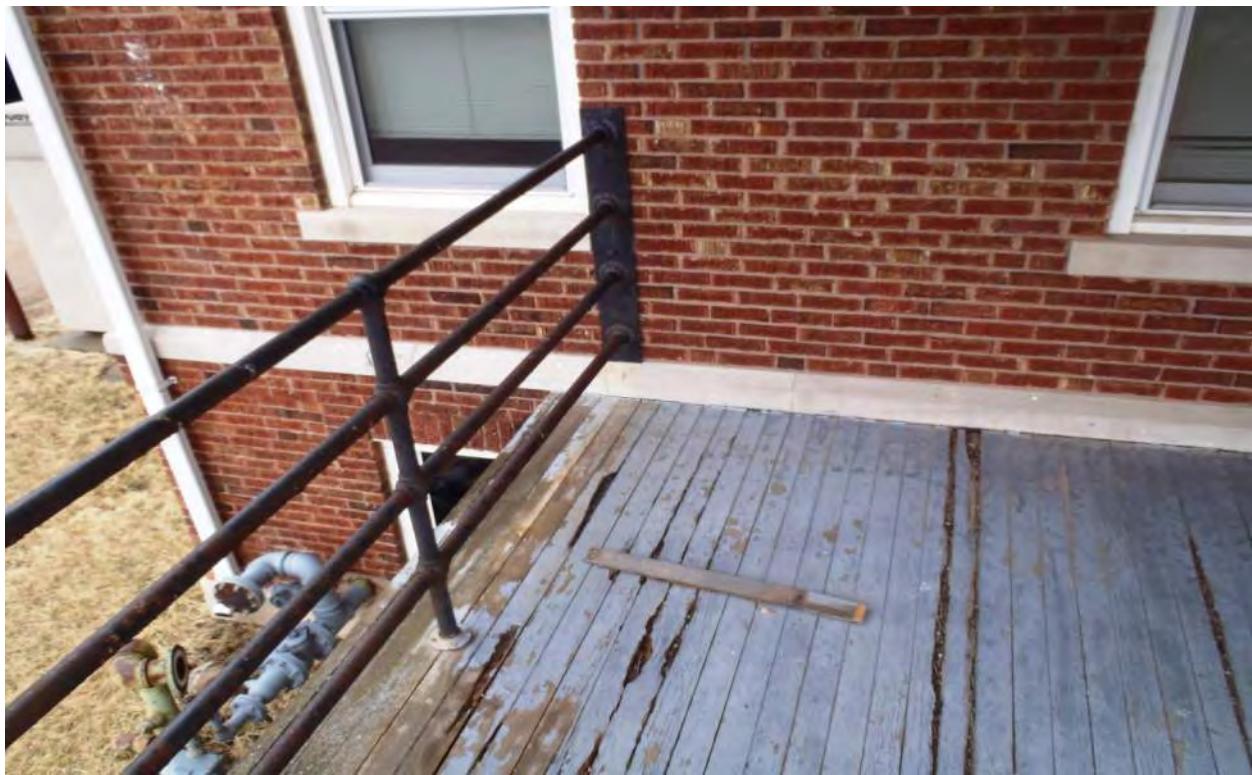
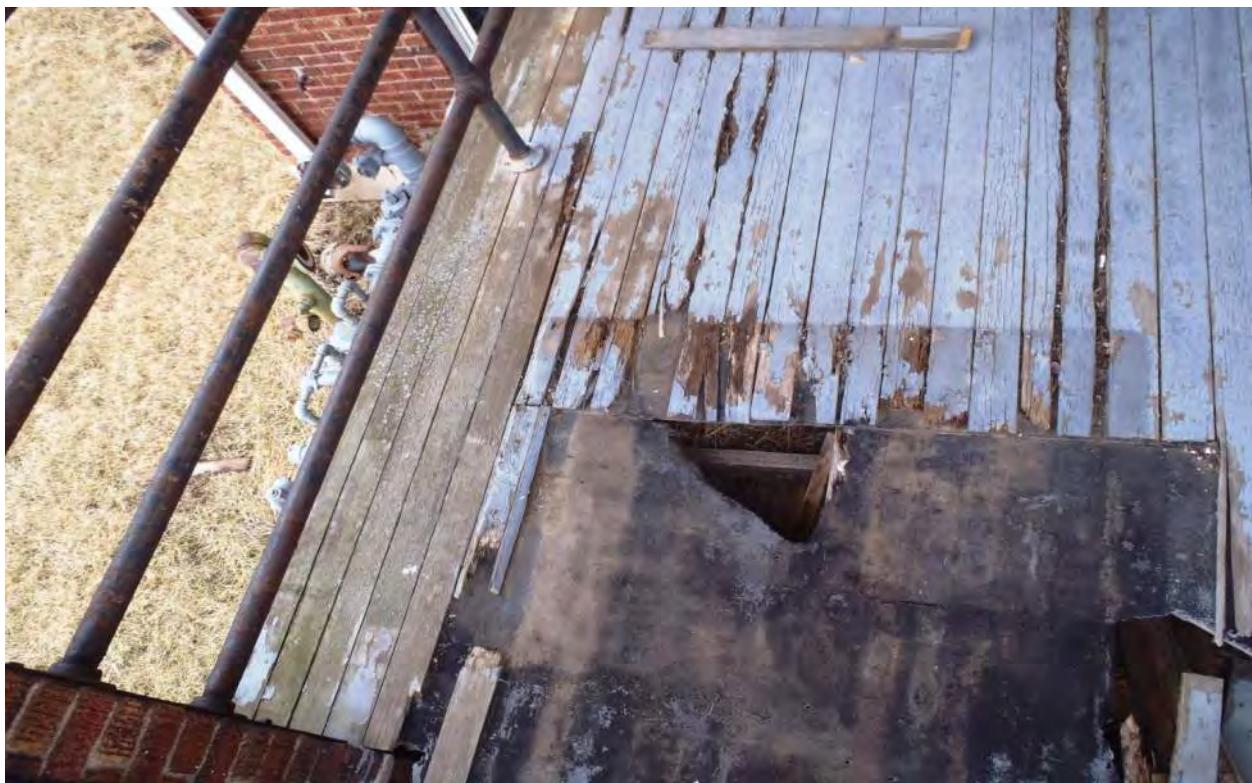
Photo 4A - West Deck Deterioration

Photo 4B - West Deck Deterioration

Photo 4C - West Deck Deterioration

Photo 4D - West Deck Deterioration

Photo 4E - West Deck Deterioration

Photo 4F - West Deck Deterioration

Photo FG - West Deck Deterioration

Photo 4H - West Deck Deterioration

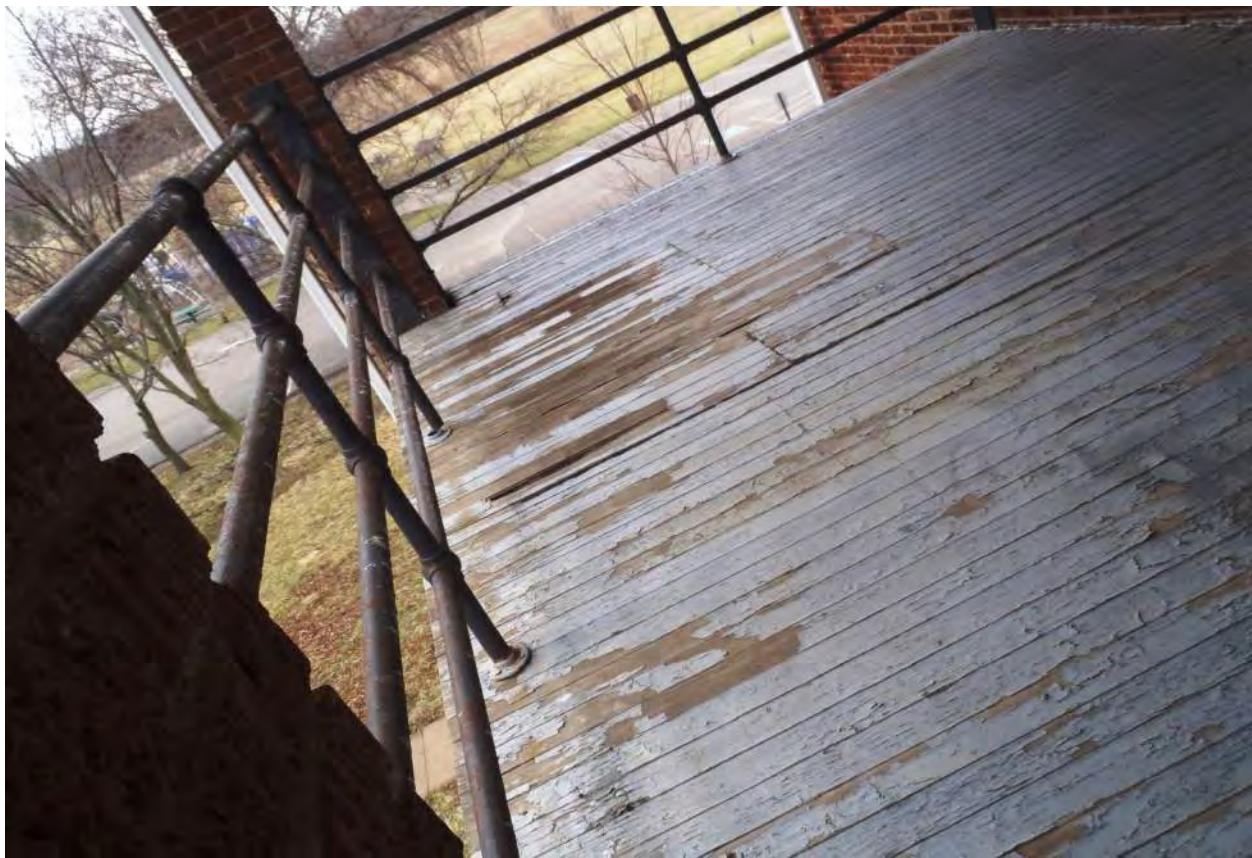
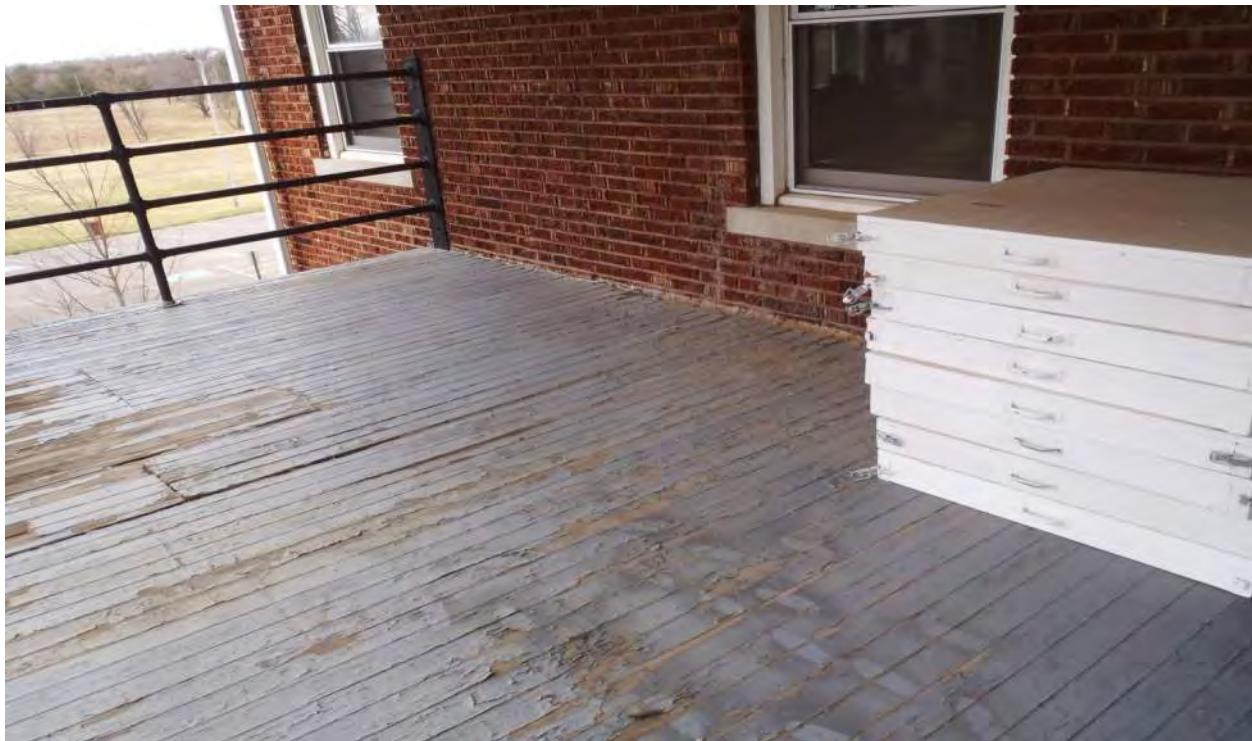
The Shawnee North Community Center is the oldest of all of the community centers observed. It was originally constructed in the 1920's as a building for the poor. The three level structure was constructed out of reinforced concrete with east and west exterior wood decks and a concrete stair and second level entry to the south. The interior of this building has performed well over the years; however, all of the exterior elements have experienced some level of distress. At the east and west ends of the buildings, exterior wood decks have significant sign of deterioration. At the west deck, the wood deck substructure was inaccessible for view; however, the wood deck is severely deteriorated and signs are present that this substructure is also probably deteriorated and in need of repair. Photo's 4A through 4H outline the condition of the west deck. This deck has been barricaded from public access and in its condition it is in need of substantial structural repair. It should not be occupied until structural repair is completed. The structural steel fire escape stair at the west deck appears to be significantly undersized and not in compliance with building code. The upper level the east wood deck was observed to be in similar condition to the west deck with a structure in need of repair which should not be occupied at this time. Photo's #4I and 4J detail this condition.

Photo 4I - Top Level Exterior Wood Deck

Photo 4J - Top Level East Exterior Wood Deck

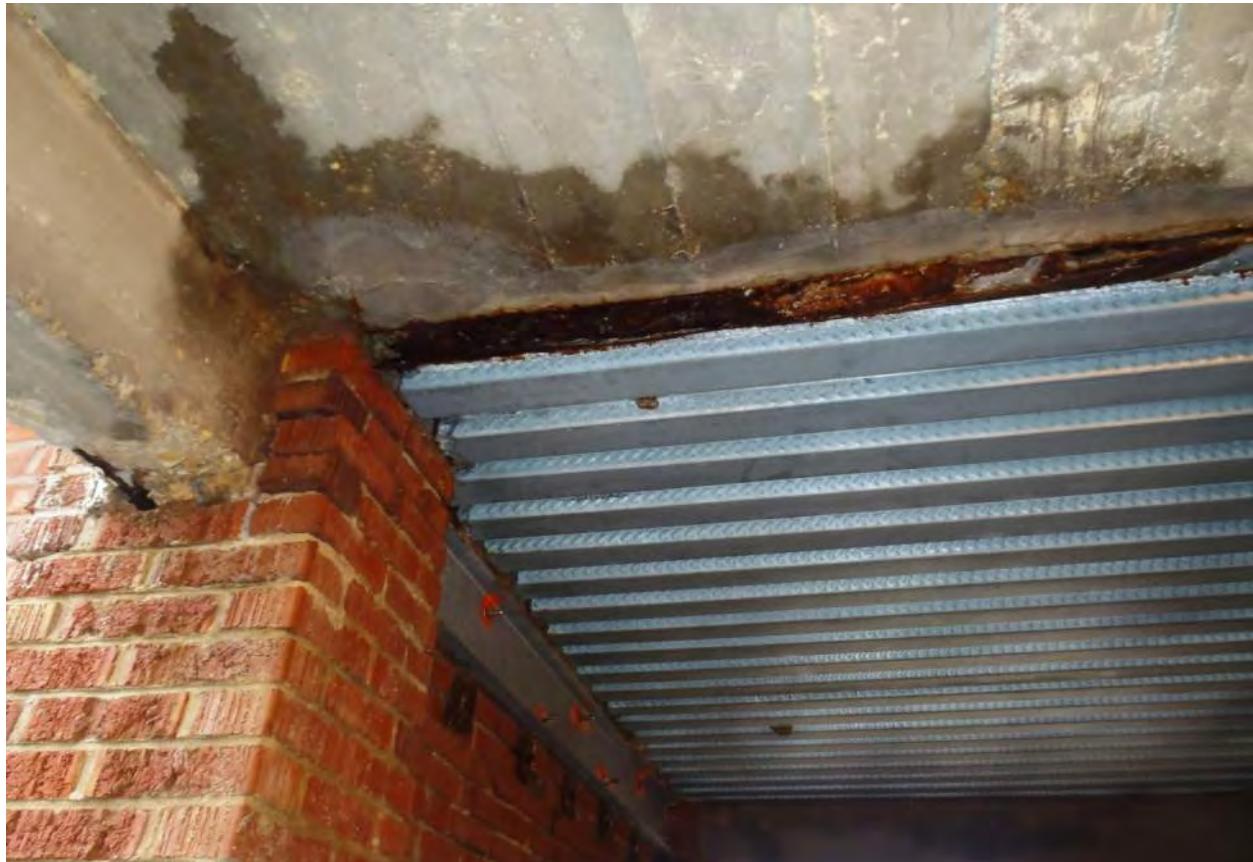
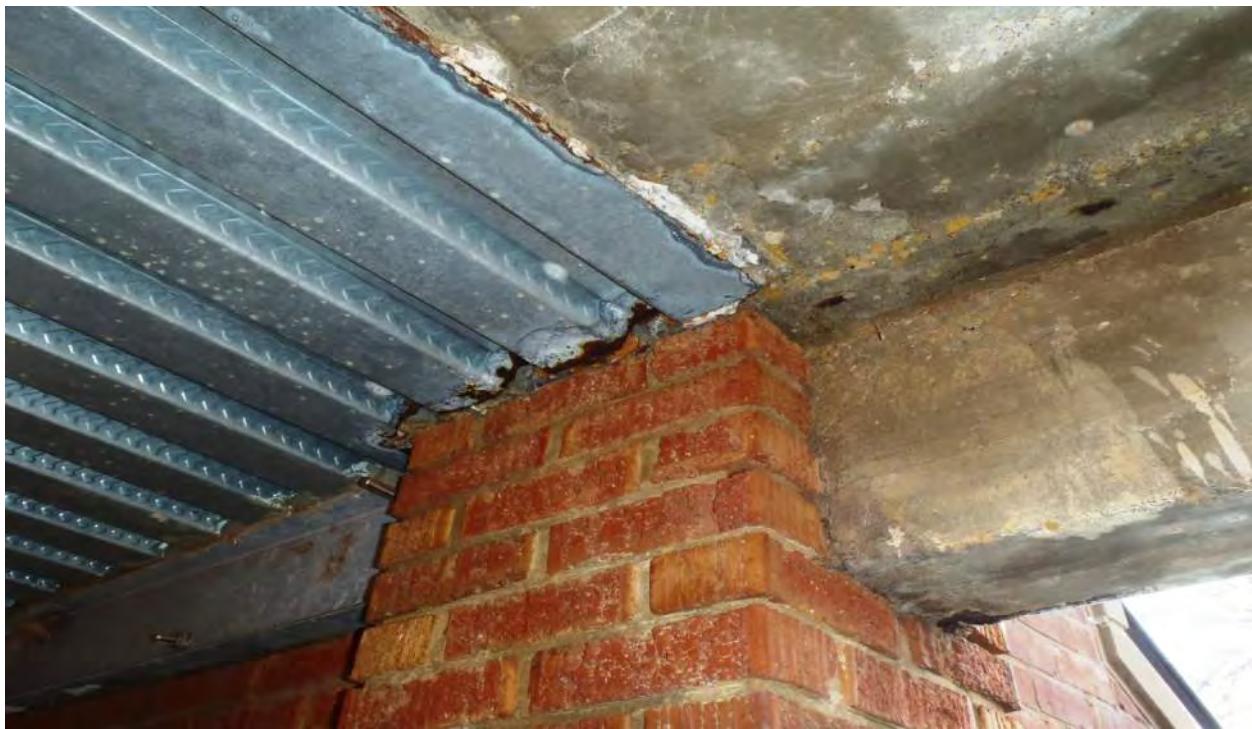
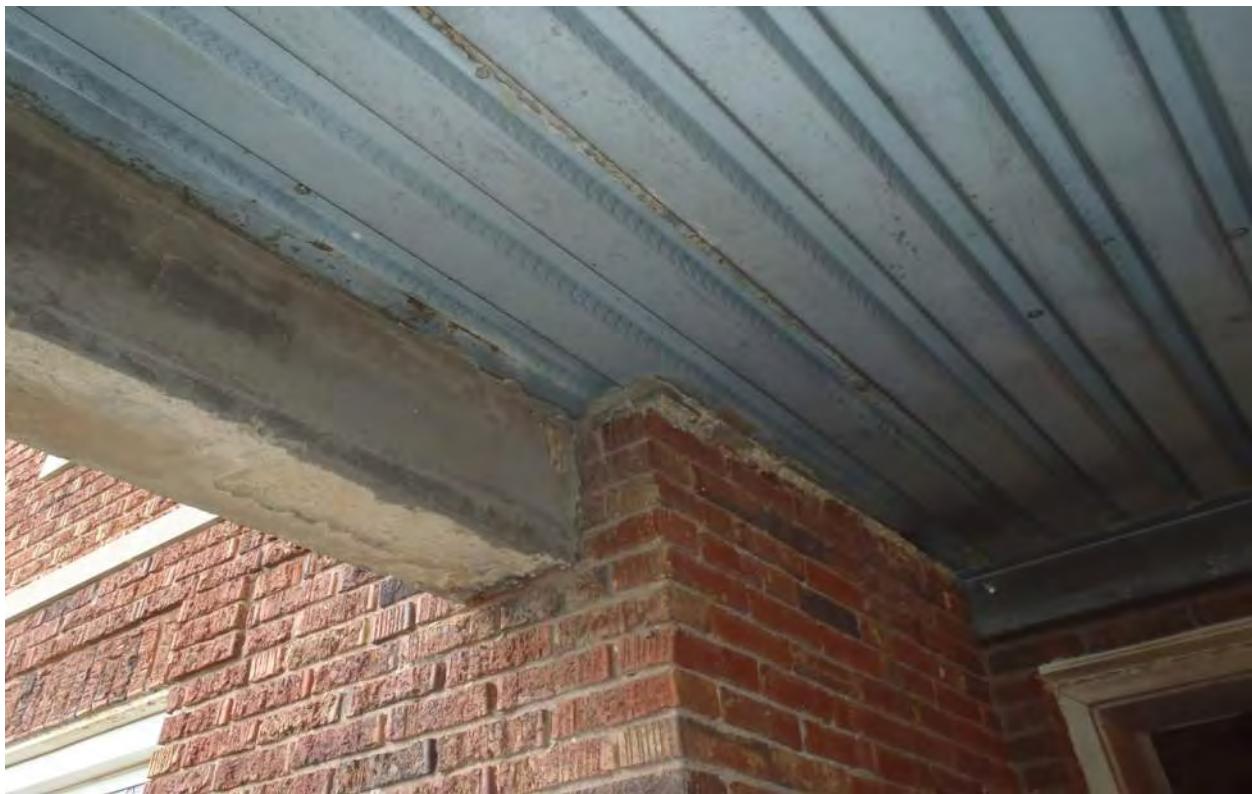
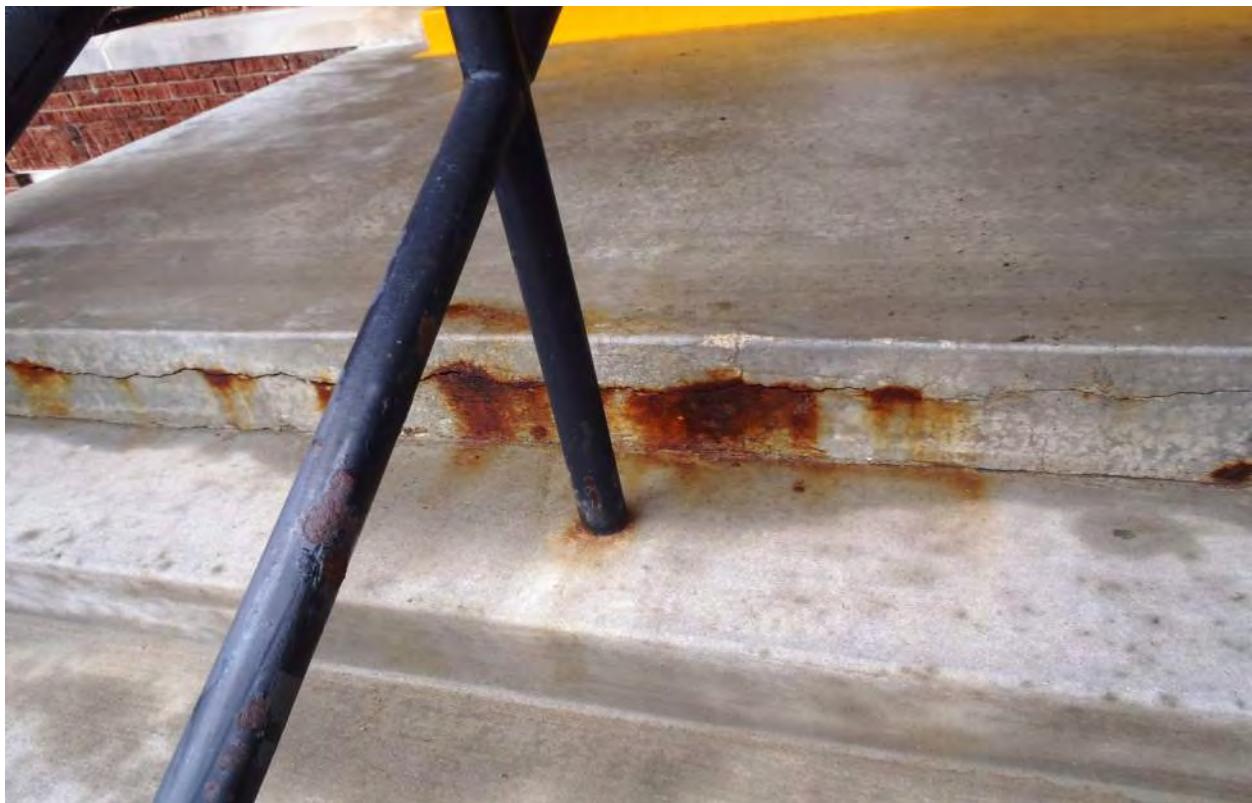
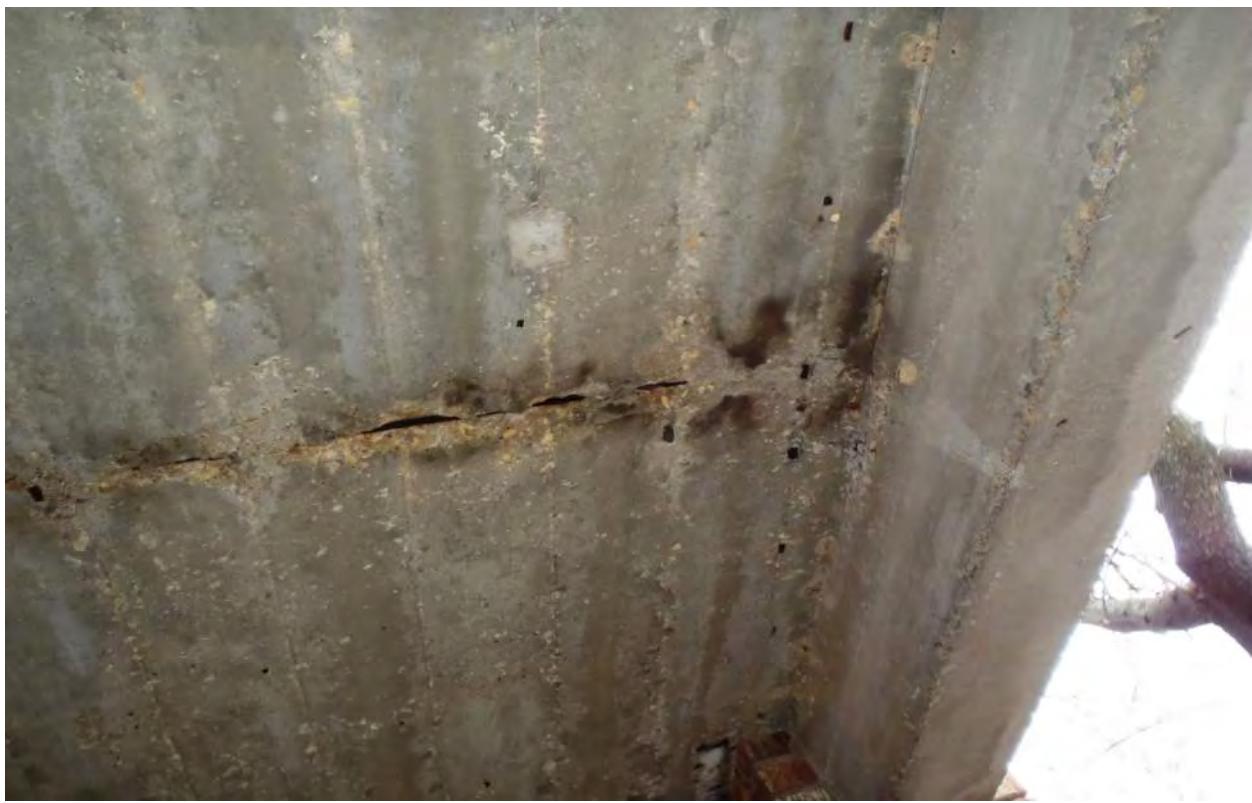
Photo 4K - Deterioration at South Exterior Concrete

Photo 4L - Deterioration at South Exterior Concrete

Photo 4M - Corrosion Deterioration at South Exterior Concrete

Photo 4N - Corrosion Deterioration at South Exterior Concrete

Photo 4O - Corrosion Deterioration at South Exterior Concrete

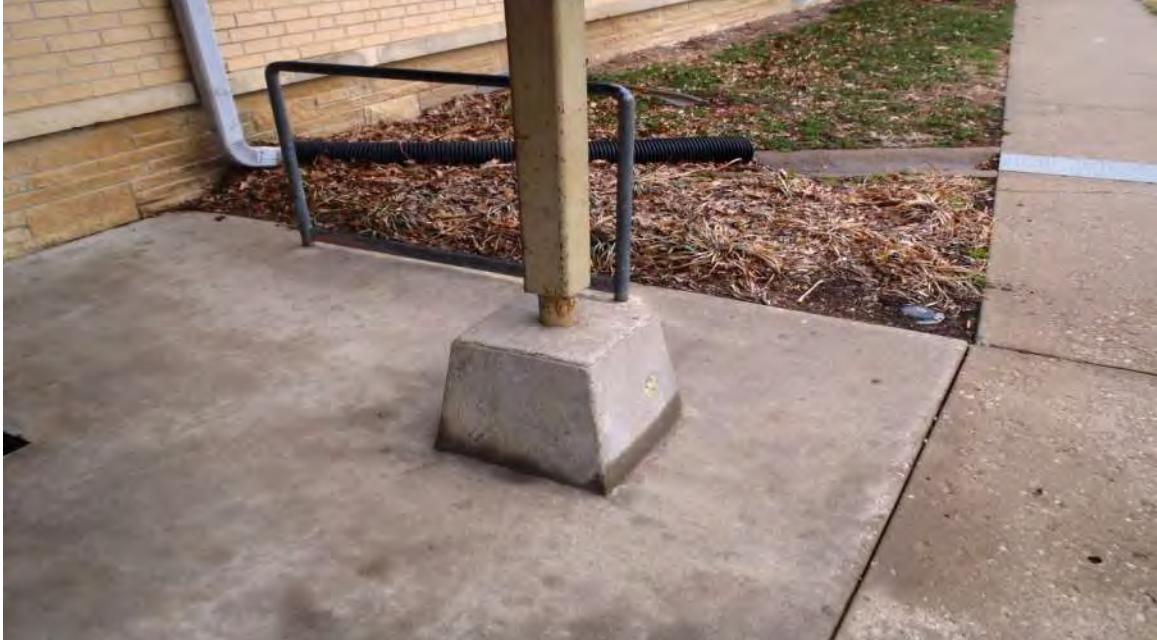
Photo 2A - Minor Corrosion at Exterior Column

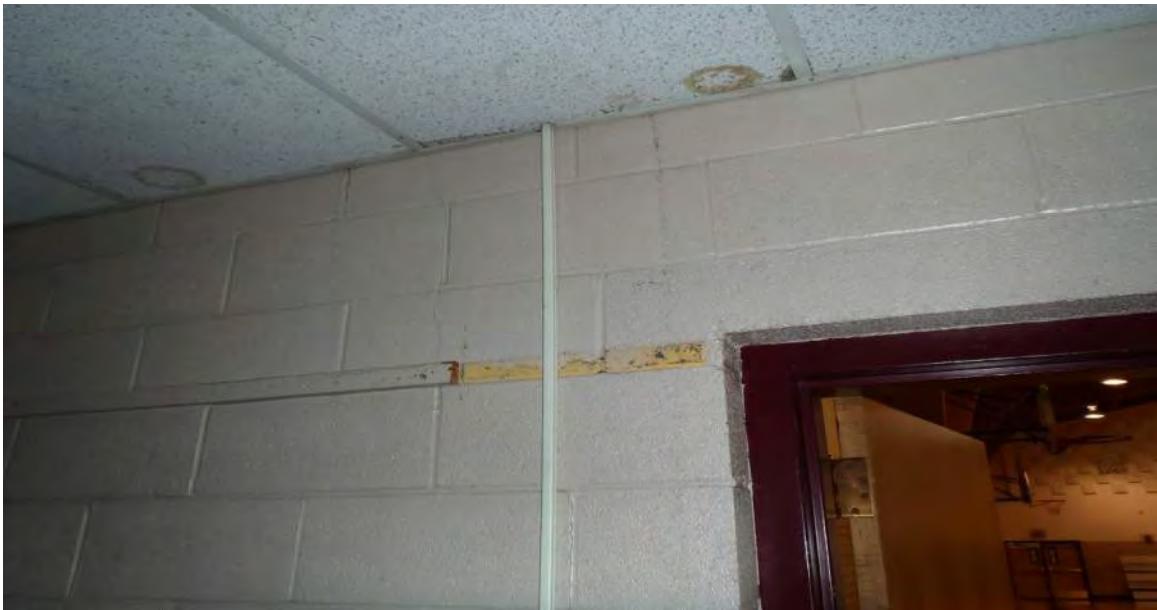
bearing masonry bearing walls. The additions appear to be constructed with steel deck atop structural steel bar joists atop wide flange beams in combination with load bearing masonry. This building complex appears to be very well constructed with minimal signs of structural concern observed during the visit. Photo's #2A details some minor corrosion at an exterior building column in need of repair/re-painting. Photo 2B details a minor settlement crack at an interior masonry wall.

Photo 2B - Minor Settlement Crack at Interior Non-Bearing Masonry Wall
