SHAWNEE COUNTY
PARKS AND RECREATION

**RECREATION
— CENTER —
ASSESSMENTS**

Topeka, Kansas

MAY 2014

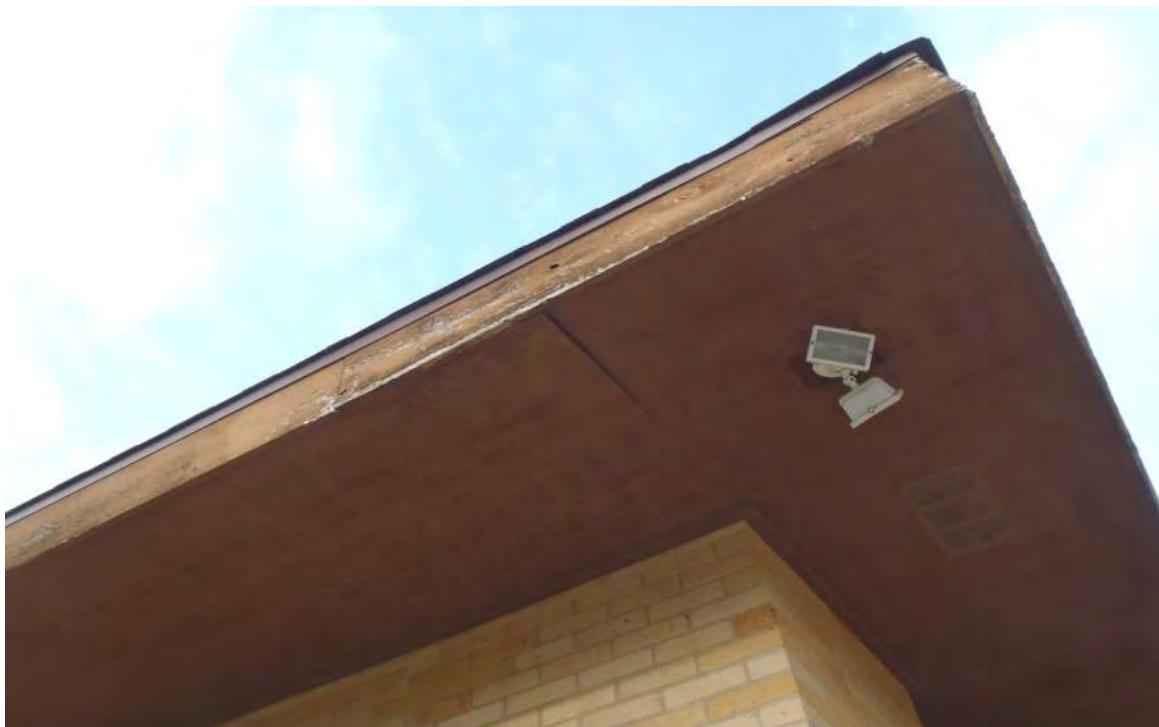
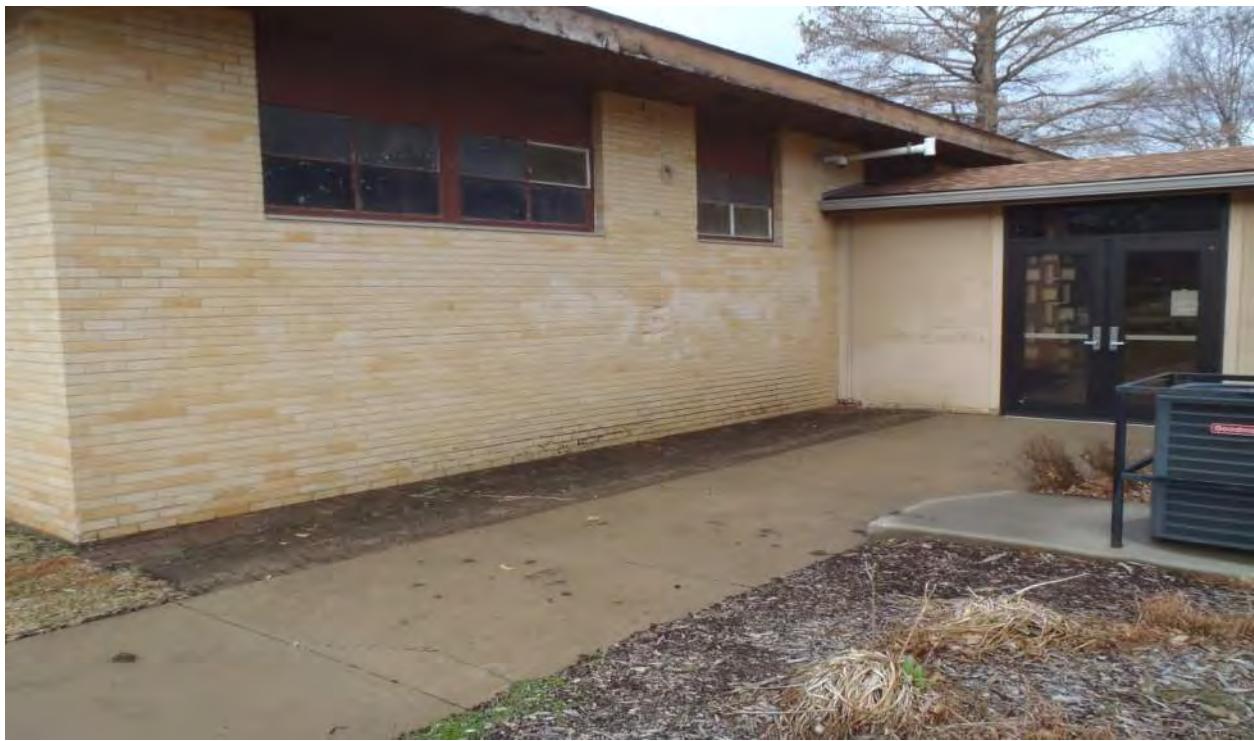
Photo #2C and 2D detail some exterior wood soffits and fascia boards showing sign of age in need of repair.

Photo 2C - Exterior Exposed Wood

Photo 2D - Exterior Exposed Wood

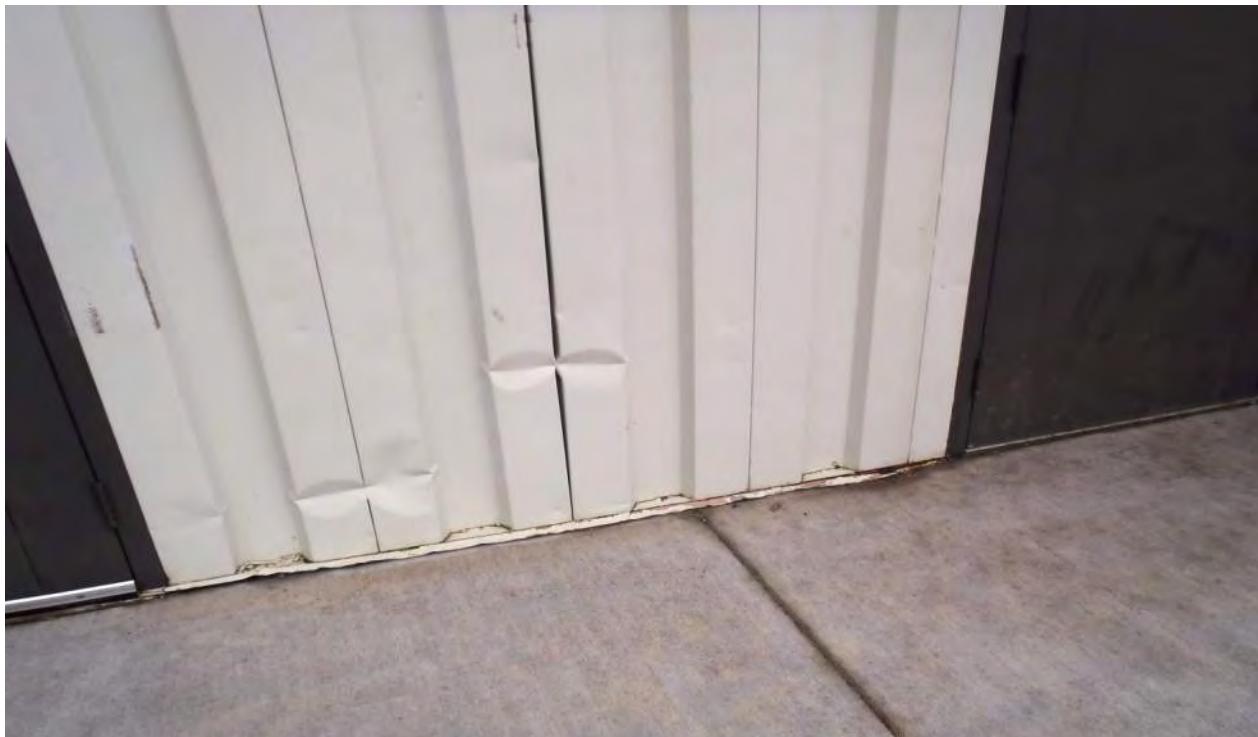
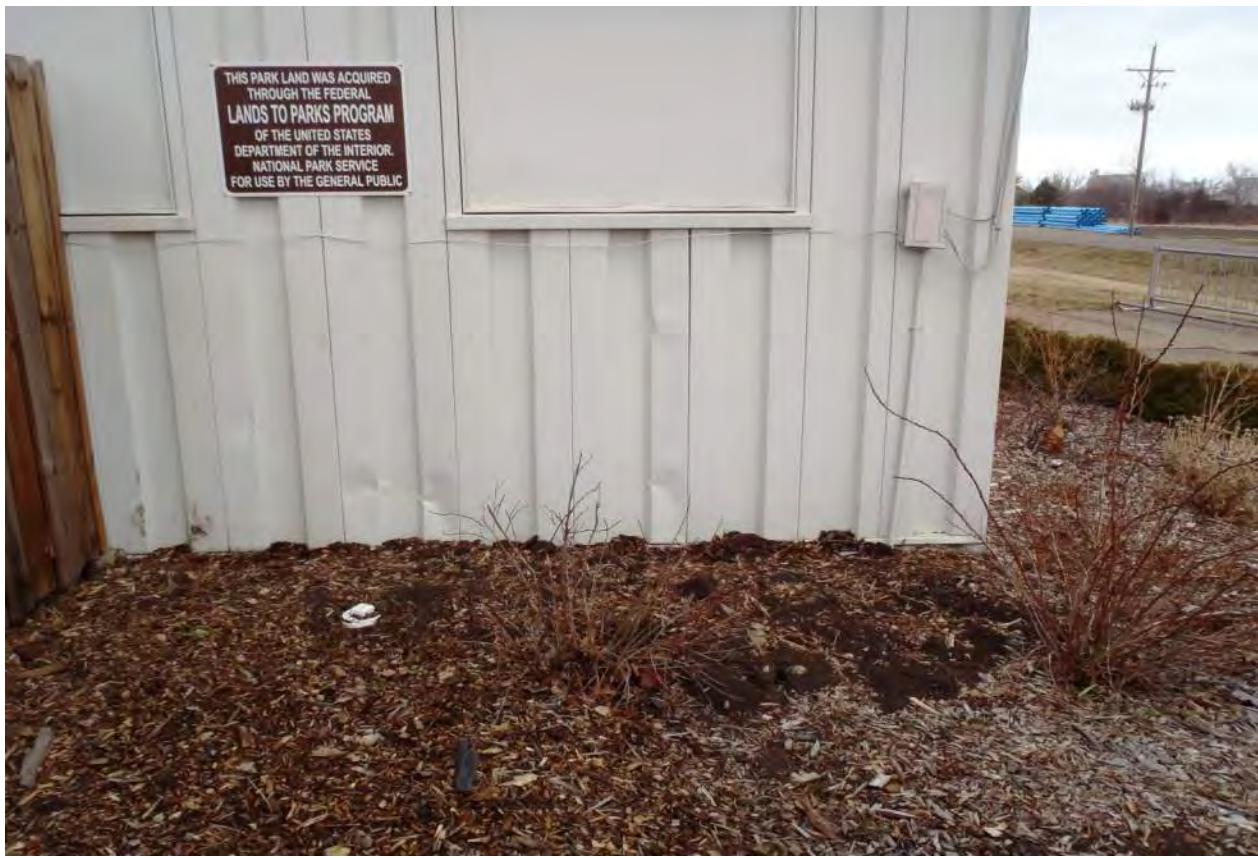
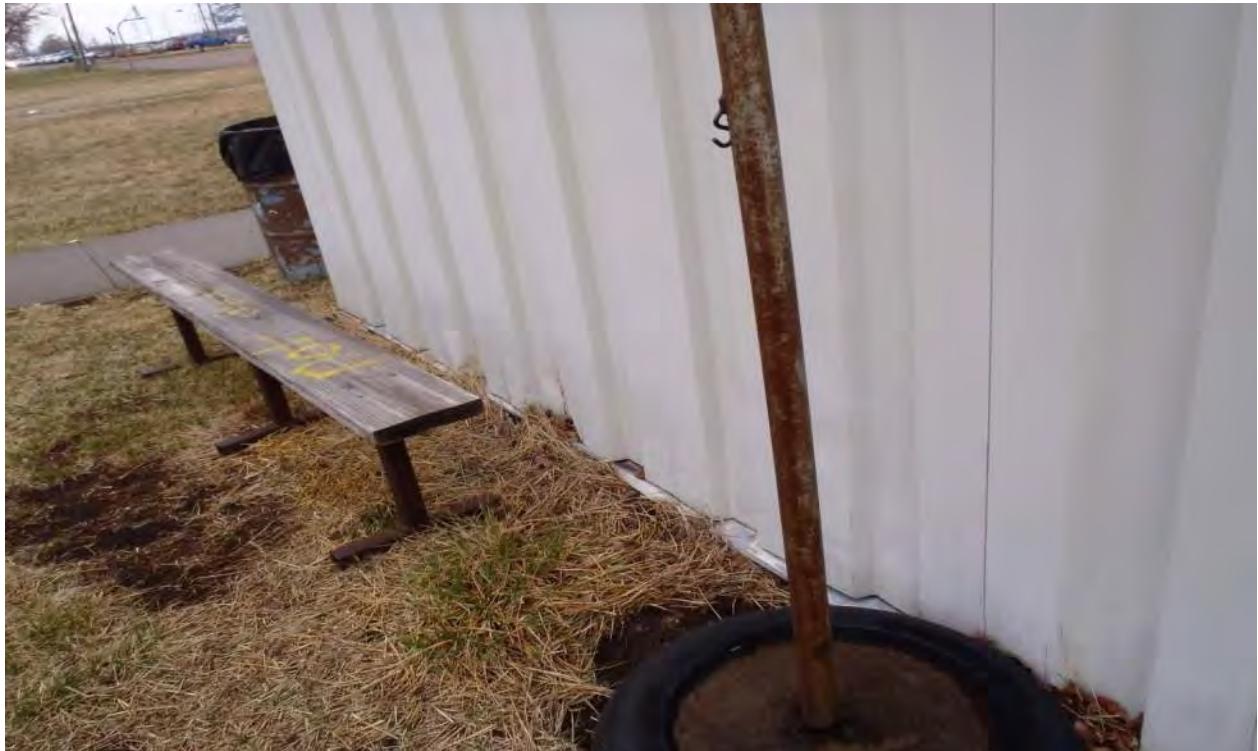
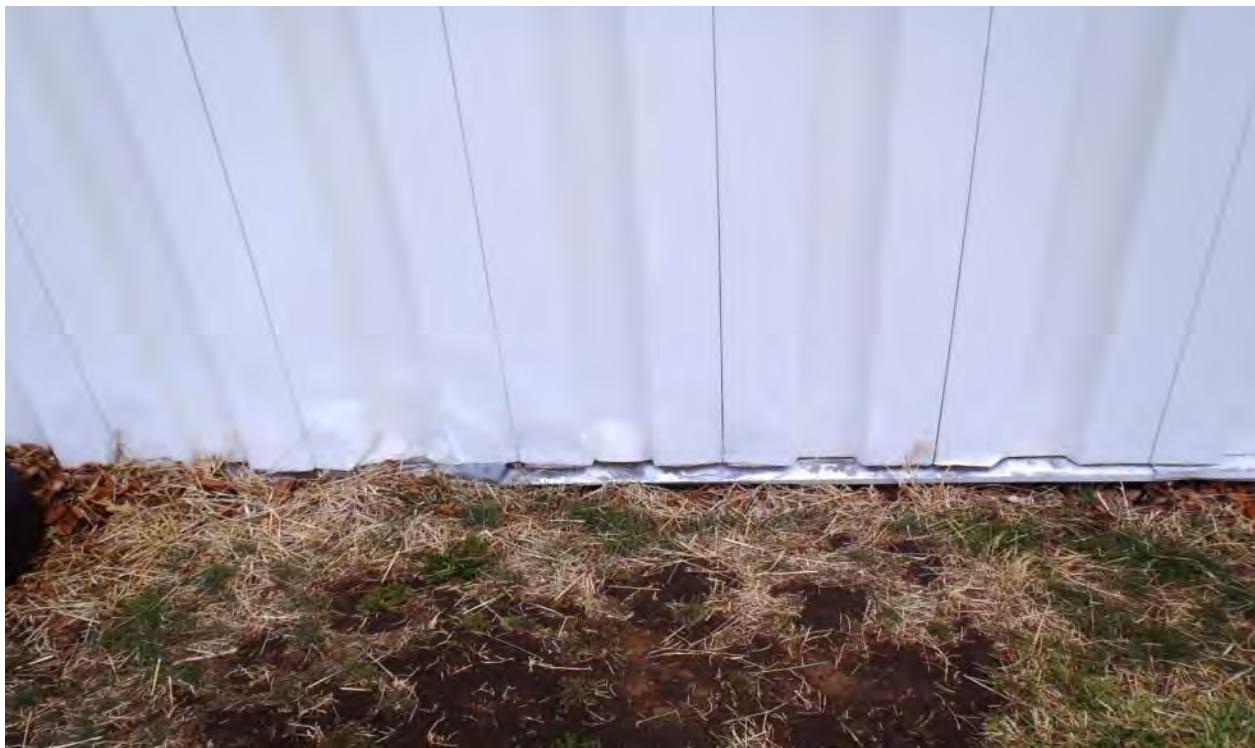
The Velma K. Paris Community Center is a single story pre-engineered metal building. This building was constructed in two phases with the first phase being approximately 20 to 30 years old and the second phase being 10 to 20 years old. Due to this building being originally part of Forbes Air Force Base, the exact age of this building could not be determined. Overall, this building appears to be very well maintained and in very good structural condition. The foundation for the structure appears to be in good condition with very minimal signs of differential foundation settlement observed. Our only comment on this facility is the condition of the exterior metal building façade. Several areas of panel damage were observed during our review. Photo's 1A through 1D detail this condition which is in need of repair:

Photo 1A - Metal Facade Panel Impact Damage

Photo 1B - Metal Facade Panel Impact Damage

Photo 1C - Metal Facade Panel Impact Damage

Photo 1D - Metal Facade Panel Impact Damage
