SHAWNEE COUNTY
PARKS AND RECREATION

**RECREATION
— CENTER —
ASSESSMENTS**

Topeka, Kansas

MAY 2014

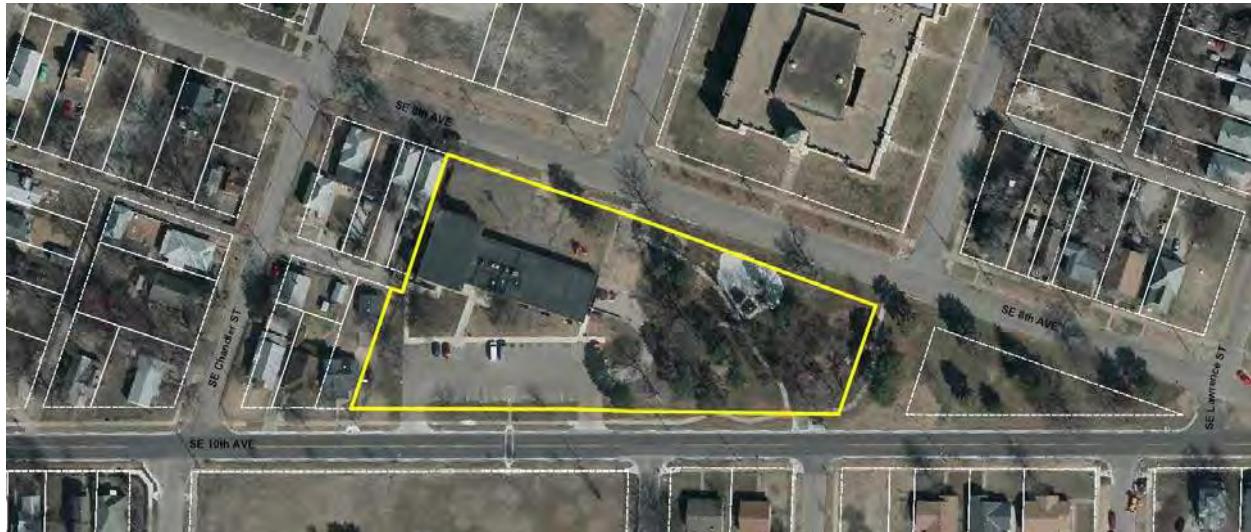
Building Access and parking

Access from the parking lot to the building's main entrance is direct and via concrete sidewalks. The main entrance was recently re-worked and appears to be accessible and compliant. The lower level is accessed from the outside via an exterior staircase and drive that extends off the parking lot. There appears to be no acceptable accessible route to the lower level as it is via the drive which appears to exceed maximum allowable slope

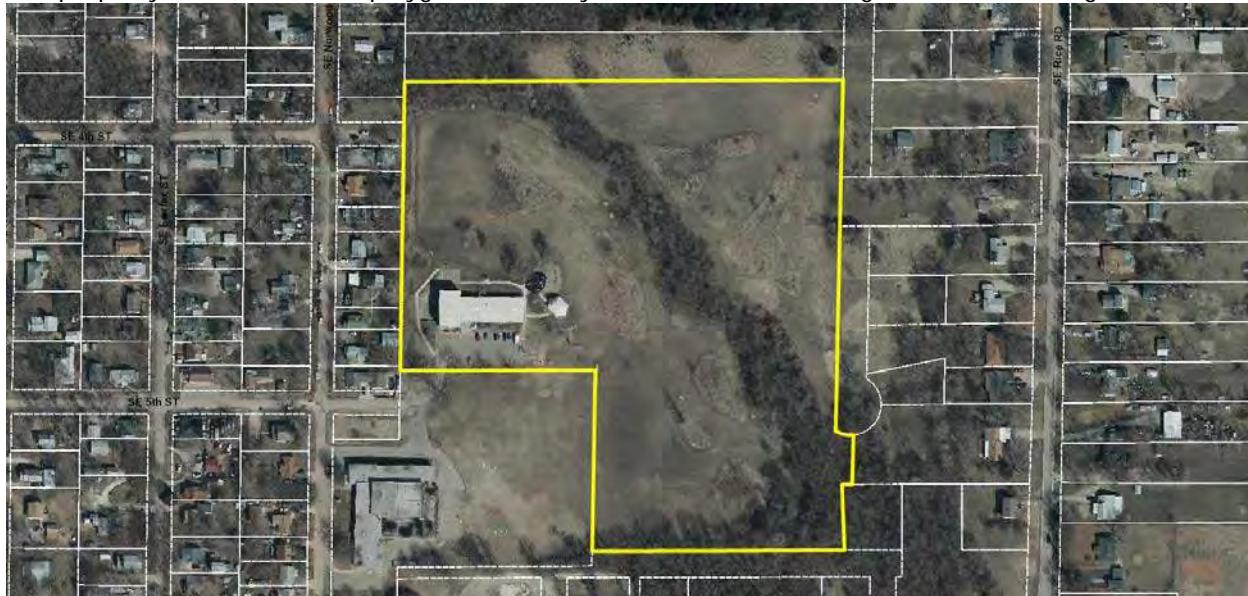
Building Access and parking

Access from the parking lot to the building's main entrance is direct and is via concrete sidewalks. There is a series of steps to the main entrance that does not allow for the main entrance to be considered accessible. Wheelchair access is available at the East end of the building on a secondary entrance via the parking lot. There is an exterior walk that leads to a lower level patio which appears to exceed allowable slope.

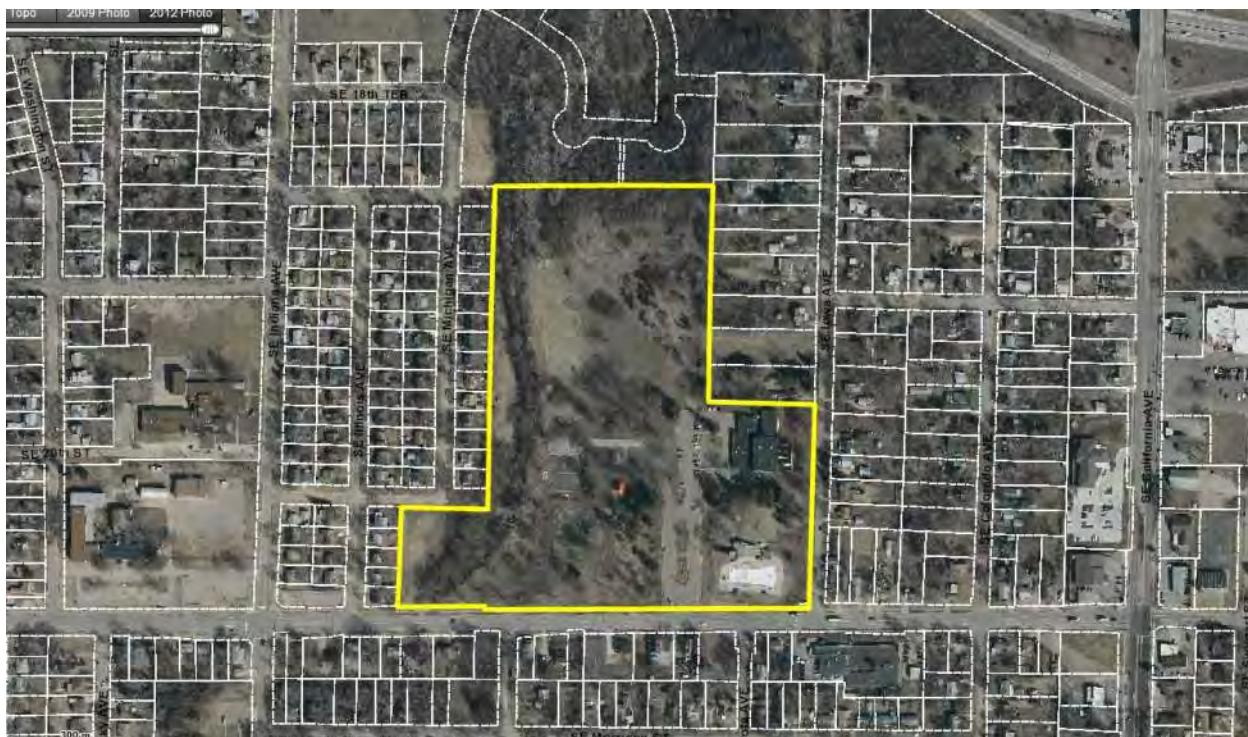
Building Access and parking

Access from the parking area to the building's main entrance is fairly removed. The building is accessed via a small sidewalk which transverses a grass island which then requires the pedestrians to cross an access drive. There are several adjacent ADA parking stalls which are fairly removed from the main entrance and should be located closer. The concrete sidewalk to the main entrance is in poor to fair condition and should be addressed.

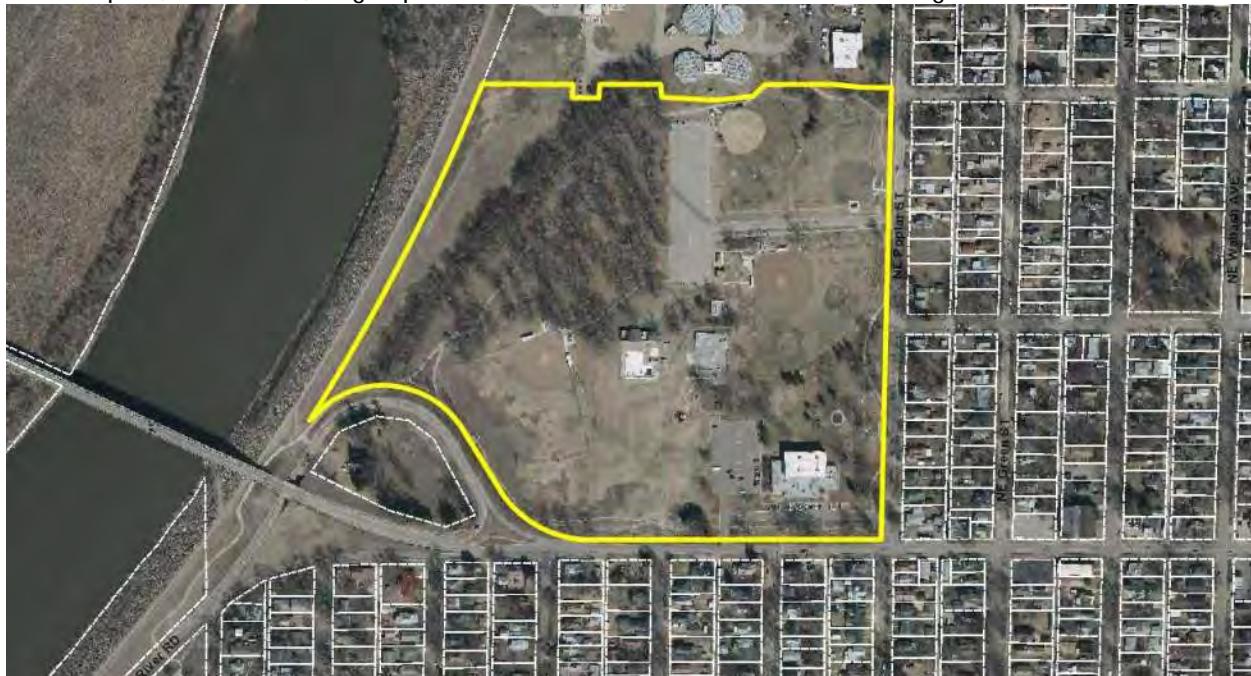
Building Access and parking

Access from the parking lot to the building is direct and via concrete sidewalks. The main entrance is at grade and appears to be accessible

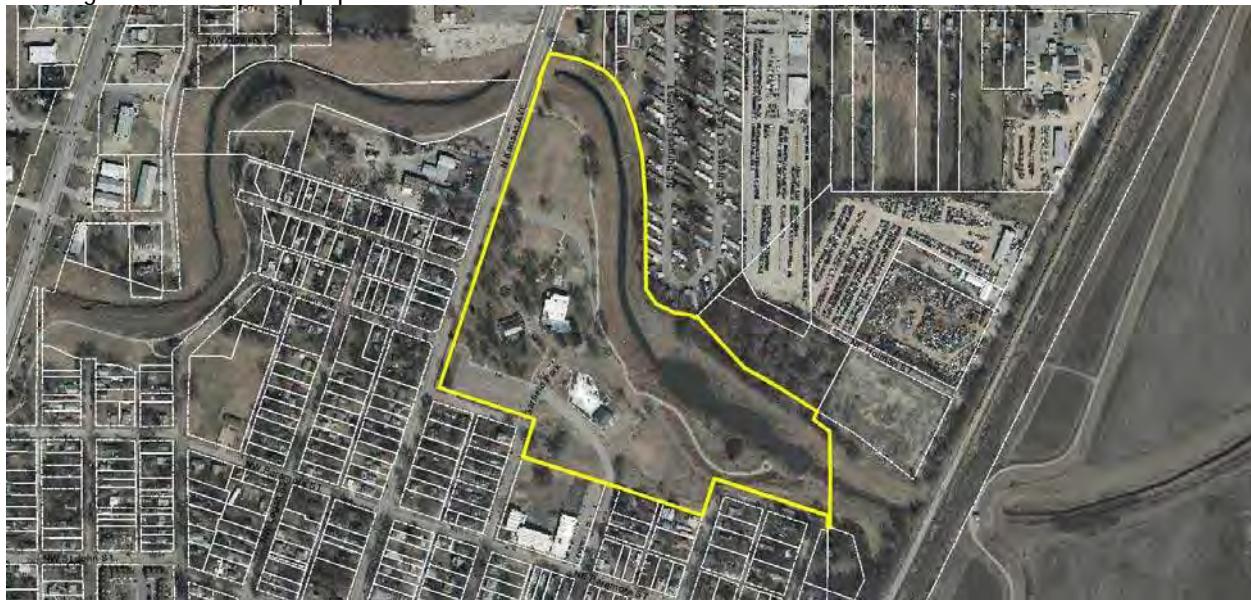
Building Access and parking

Access from the parking lot is fairly removed from the building's main entrance. It is via concrete sidewalks and requires crossing access drives. Accessible parking is fairly close and but is located across an access drive. The main entrance is at grade and appears to be accessible

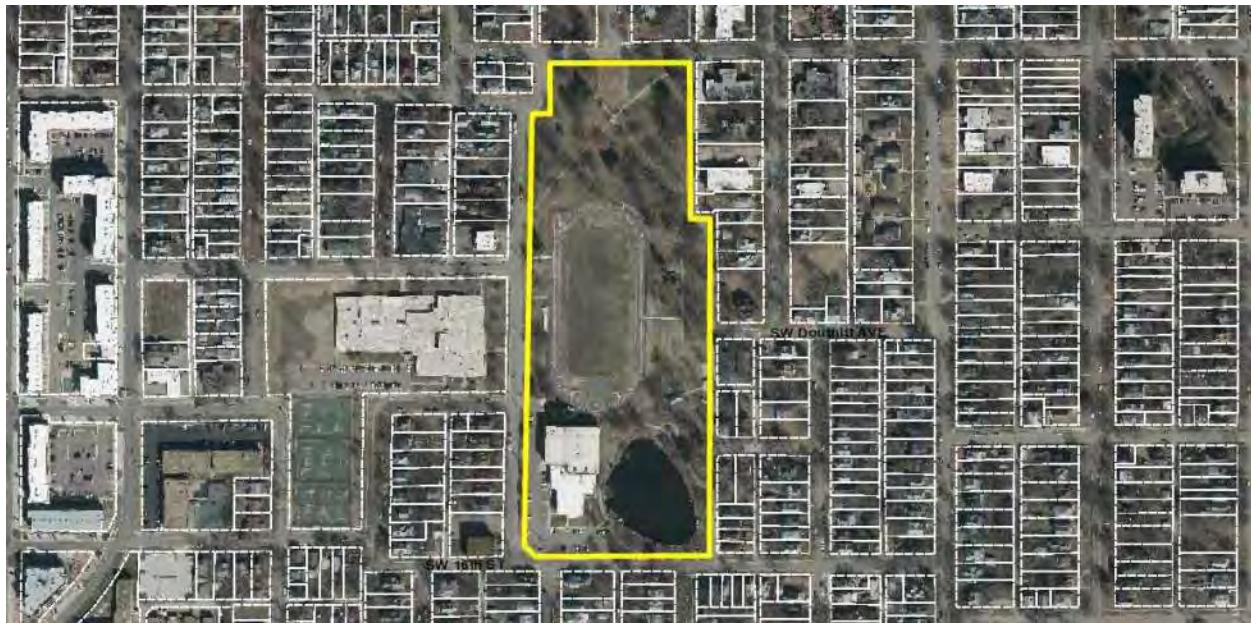
Building Access and parking

Access from the parking lot to the building is direct and via concrete sidewalks. The main entrance is elevated from the parking level. ADA access is via a ramp alongside the building. The ramp appears to

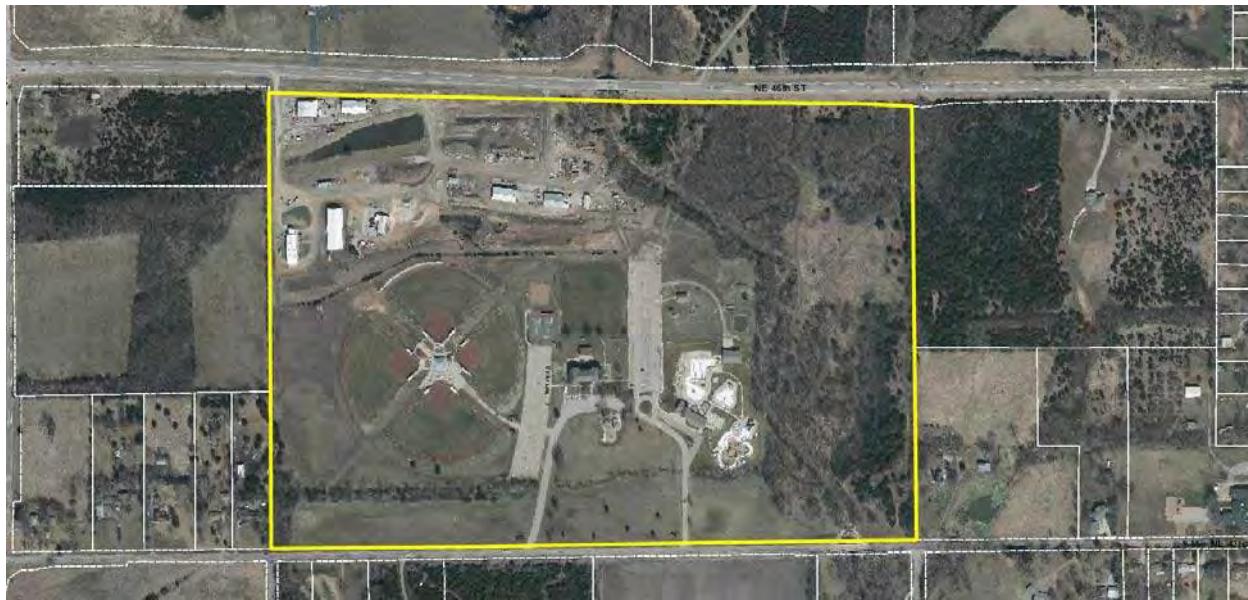
Building Access and parking

Access from the parking lot to the building is fairly direct and via concrete sidewalks. The main entrance is elevated and is not ADA compliant.

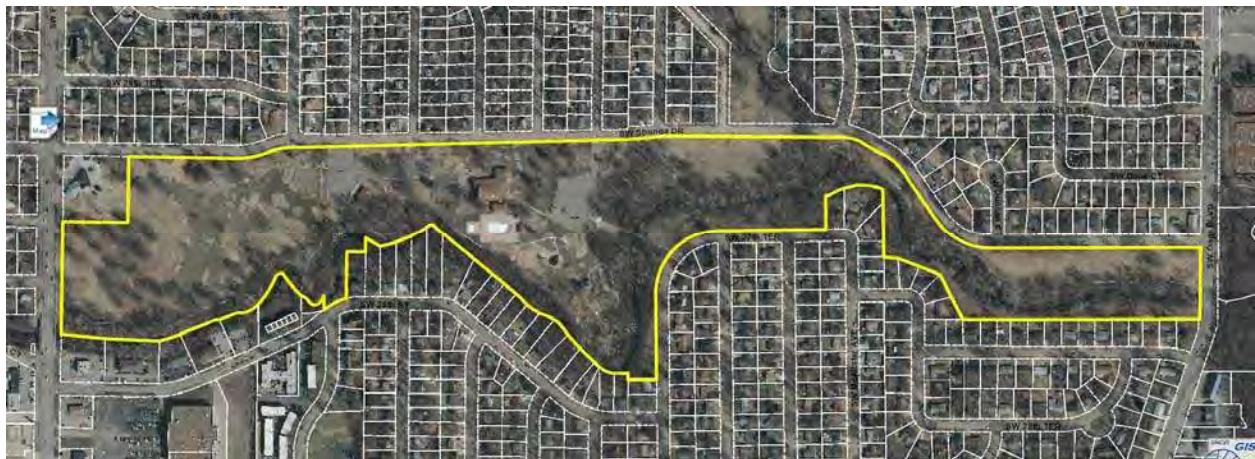
Building Access and parking

Access from the parking lot to the building is fairly removed. Access is via a concrete sidewalk which appears to exceed allowable slope in some areas. The main entrance is at grade and appears to be accessible.

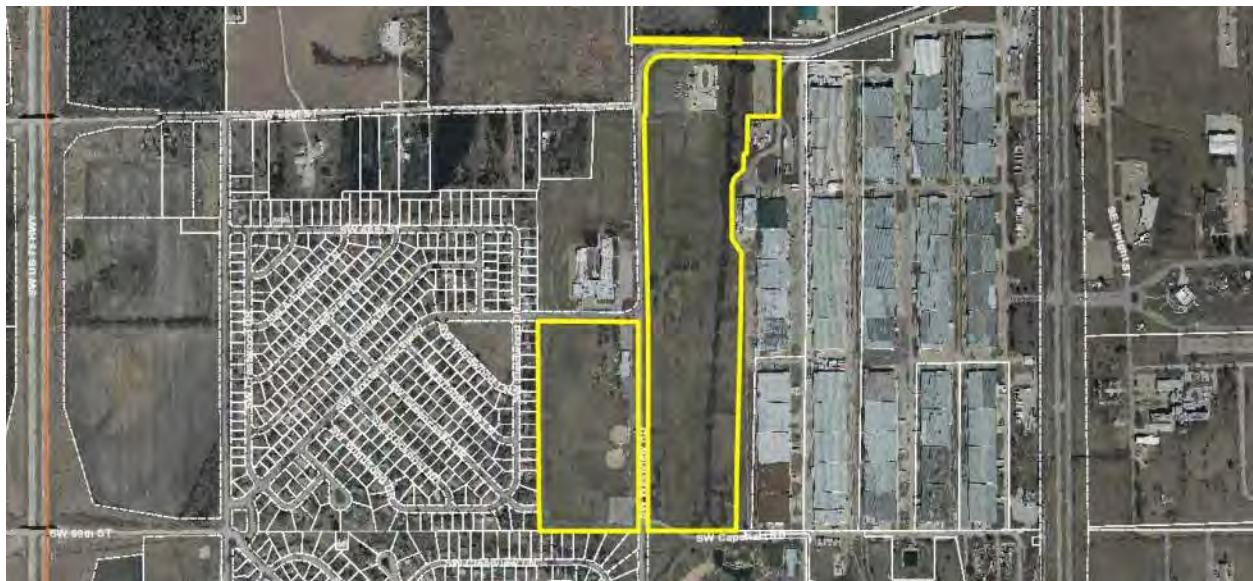
Building Access and parking

Access from the parking lot to the building is direct. Access to main entrance is via a concrete sidewalk. The main entrance is at grade and appears to be accessible. Accessible parking is located adjacent to the secondary entrance on the North side of the building.
